## STAR ONLINE PUBLICATION

**Case Number:** S2008000059 – REV. B

**Symptom/Vehicle Issue:** Error Code 20 Message On the Radio Screen

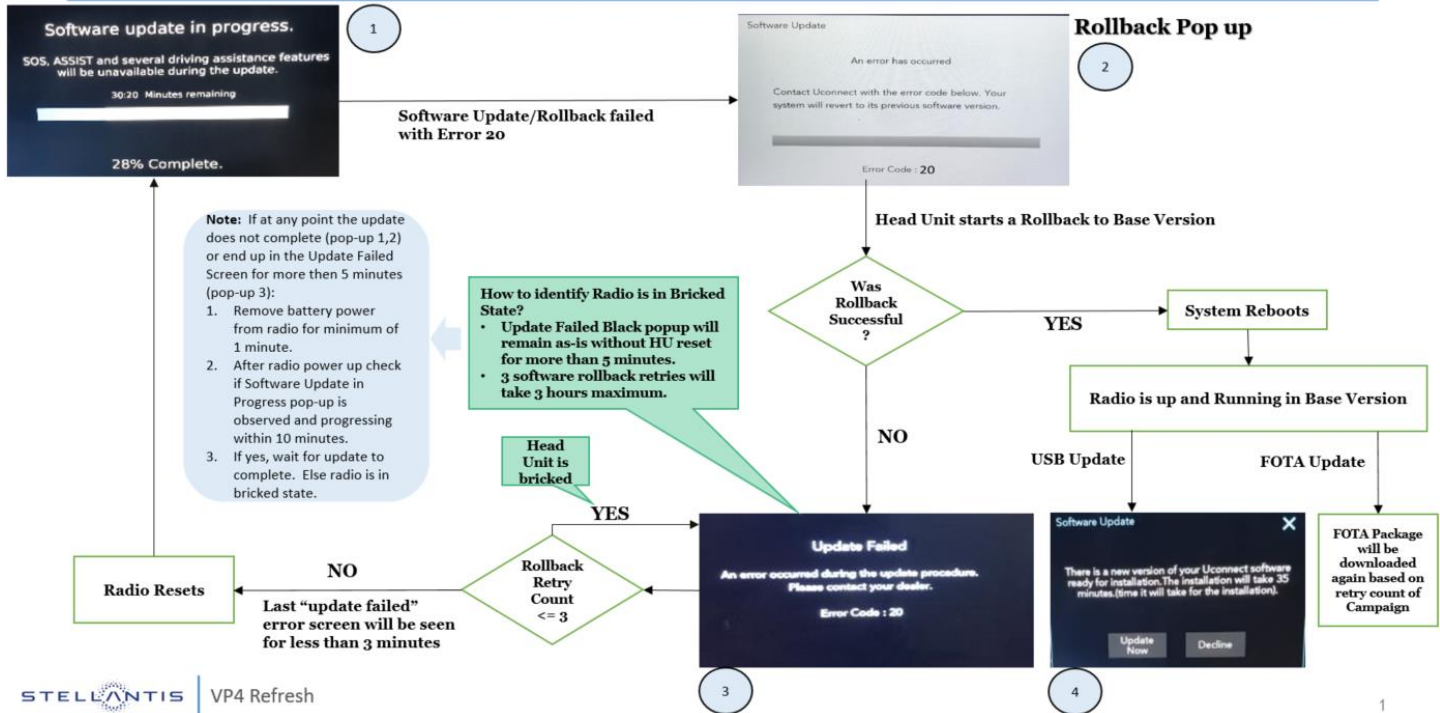
### SOFTWARE UPDATE ERROR CODE 20 FLOW CHART

**Technician Observation:** Customer might see an error message “Error code 20” during radio software update either through USB or over the air (FOTA).

**Discussion:** This is most likely caused by process or file corruption. The head unit will try to roll back to the base software, please leave the vehicle ignition on and let radio recover on its own.

1. Please DO NOT interrupt the update process by Ignition off the vehicle or disconnecting the radio while the screen showing “**Software Update in Progress**” or “**An Error Has Occurred**”
2. When you see “**Update Failed**” screen, please verify and see if the message stuck for over 5 minutes.
3. If the radio shows “**Update Failed**” screen for over 5 minutes, please try to remove battery power cable.
4. Reconnect battery power after 1 minute. Monitor if the “**Software Update in Progress**” pops up on the screen within 10 minutes.
5. Replace the radio if “**Update Failed**” screen remains.
