STAR ONLINE PUBLICATION

Case Number: S2114000003

Release Date: June 2021

Symptom/Vehicle Issue: Start/Stall And Malfunction Indicator Lamp (MIL) Illumination After Replacement Fuel Line Chassis Bundle Installation.

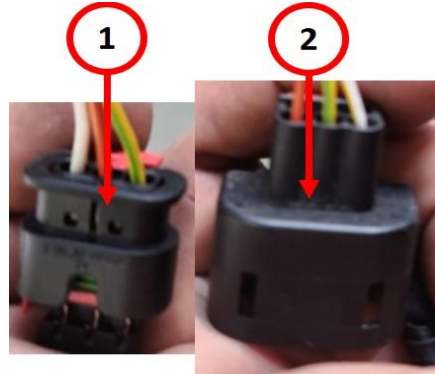
Figure 1

The electrical connector for the newer design fuel pressure sensors are different from the older design. See ([Figure 1](#)). This will require a new electrical connector to be installed (pn# 68137864AA) in order to utilize the new fuel line bundle.

1. New Design
2. Old Design

NOTE: The circuit pin locations have also moved to different locations on the new design sensor.

NOTE: Replacement engine harnesses, including the harnesses on replacement complete engine assemblies are also equipped with the new design sensor electrical connector. When replacing these components, please also replace the fuel line bundle. Do not swap the electrical connectors.

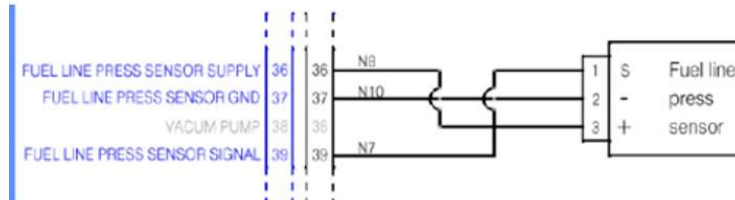
Figure 2

Original Design

New Design

When installing the new connector, it is important to place the circuits in the correct pin location for the new design sensor. Looking at the back of the connector (wire insertion side) with the locking tab up, and starting from the left. Circuit N7 (OG) has moved from pin 1 to pin 2. Circuit N10 (YE/GN) has moved from pin 2 to pin 3. Circuit N8 (WH/YL) has moved from pin 3 to pin 1. See (Figure 2).
