STAR ONLINE PUBLICATION

Case Number: S1918000008 Rev. B

Release Date: June 2021

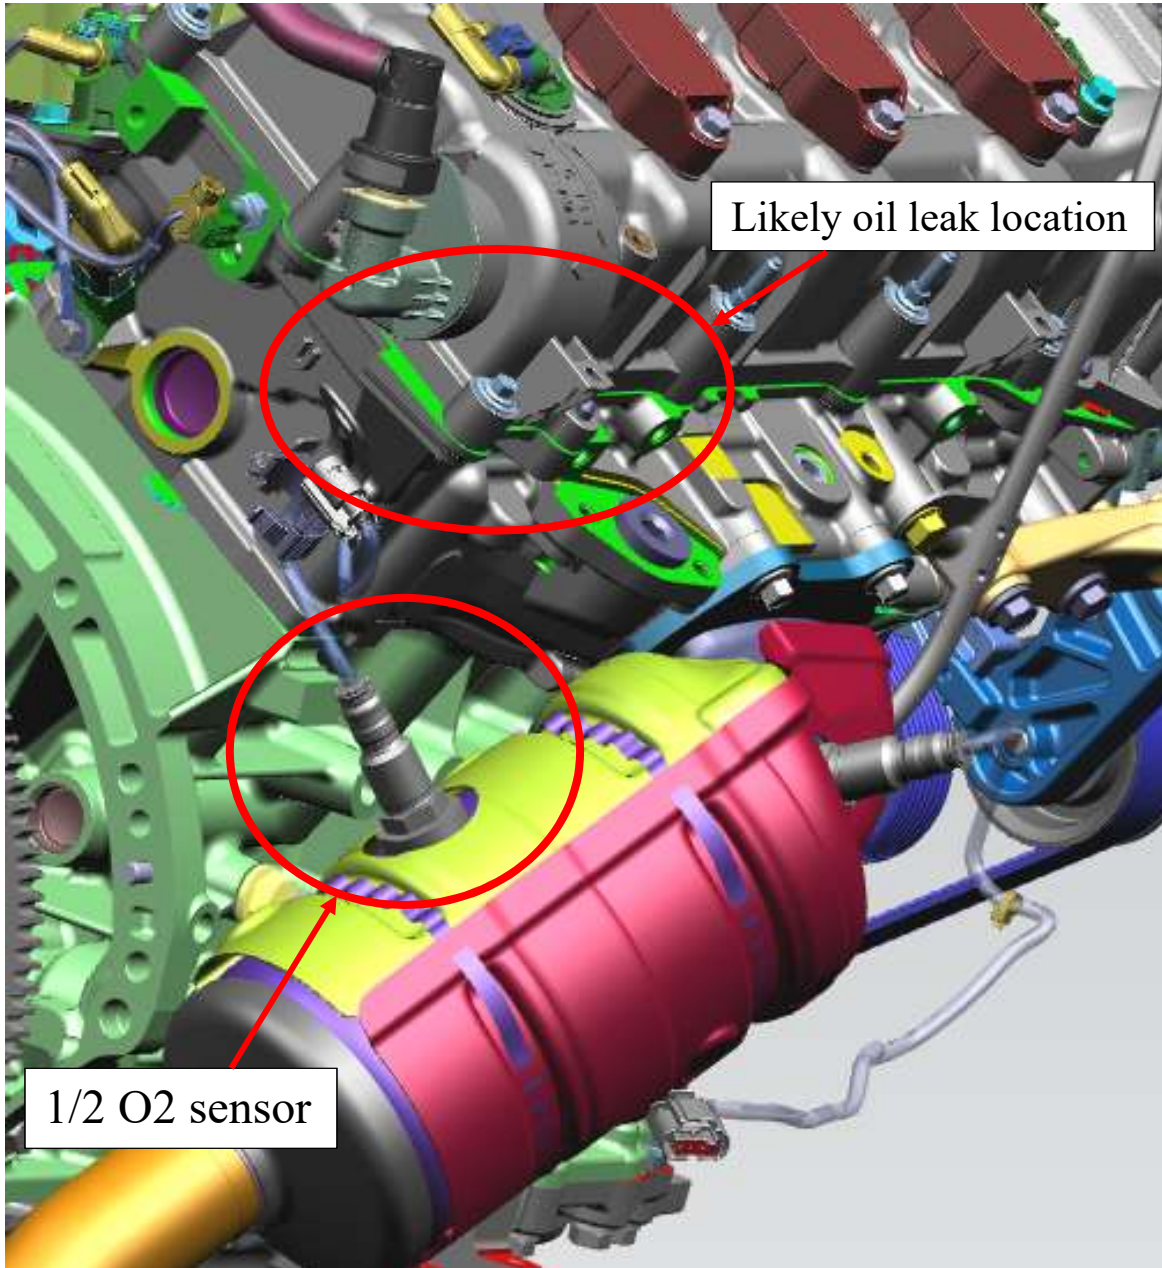
Symptom/Vehicle Issue: Customer's complaint may include a MIL-on with one or more of the following DTCs (Active, Pending, or Stored) in the PCM: P0133, P0137, P0171, P0300, P2096. The root cause could be due to oil leaking from Bank 1 valve cover seal on to the 1/2 (Bank 1 downstream) O2 sensor. This can adversely affect the 1/2 O2 sensor signal reading and lead to listed DTCs. Before performing normal diagnostic routines for the above codes, check for the condition listed above.

Discussion: Inspect the 1/2 O2 sensor for signs of oil on top of the sensor. If oil is found, replace the 1/2 O2 sensor and inspect Bank 1 valve cover for signs of leakage. If leakage found, repair the valve cover leak as necessary.
