STAR ONLINE PUBLICATION

Case Number: S201400002 REV. B

Symptom/Vehicle Issue: Metal Or Other Debris Contamination In The High Pressure Fuel System. Star Parts Restriction Process

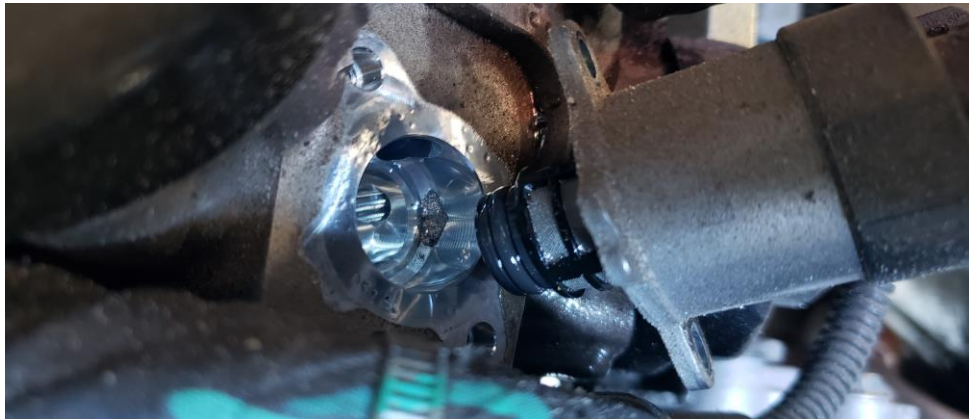
Figure 1.

- e. You will then be prompted to input an email address. Input FCA_DC@cummins.com as the email address and be sure to click "Add" after doing so otherwise the email will not be sent. After selecting add click continue.
3. Inspect the fuel system for external contamination and describe in STAR Case Narrative
4. Take a clear photo of the FQS and FQS Bore of the pump to confirm the failure (**Figure 1**).
