STAR ONLINE PUBLICATION

Case Number: S2008000132 - Rev. A

Symptom/Vehicle Issue: U11E9 Lost Communication With AGS (Active Grille Shutter), Malfunction Indicator Lamp (MIL) Illuminated

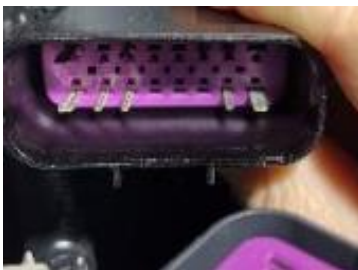
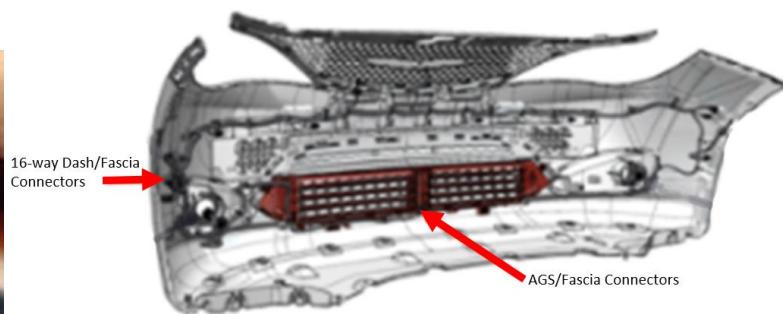
1. Inspect the wiring near the 16-way XY101A Dash to Fascia Connector for nicks and cuts. Also disconnect the connector and inspect for corrosion.

1. If corrosion or damage is present at the XY101A connector. Use connector kit 68497543AA to repair the 16-way dash side connector and replace the fascia side harness. A connector repair kit 68500834AA for the fascia side connector will be available in the future.
2. If corrosion is present in the AGS connector, replace the AGS. Do not add dielectric grease to the AGS/fascia connectors. If corrosion is present in the fascia connector, repair it using connector kit 68396618AB or replace the harness as necessary.

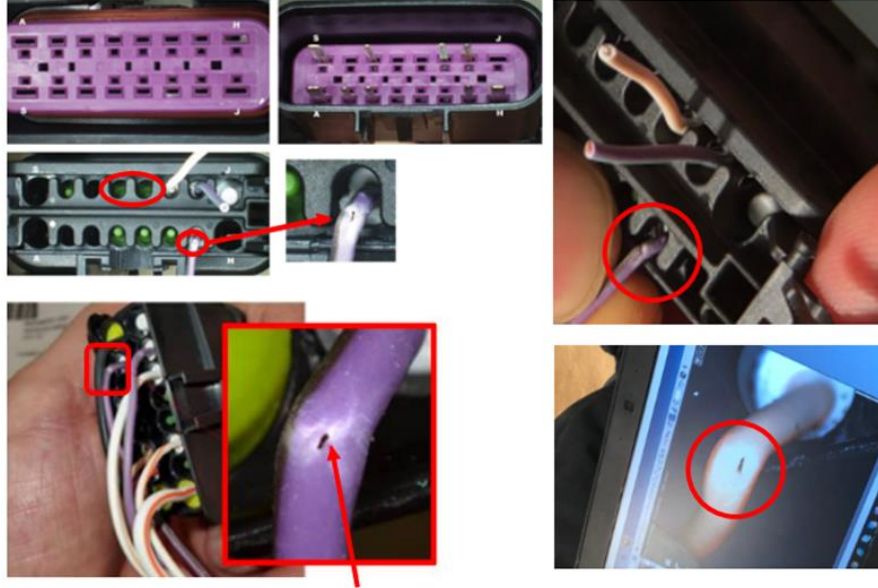
16-Way XY101A Inline Connector Damage

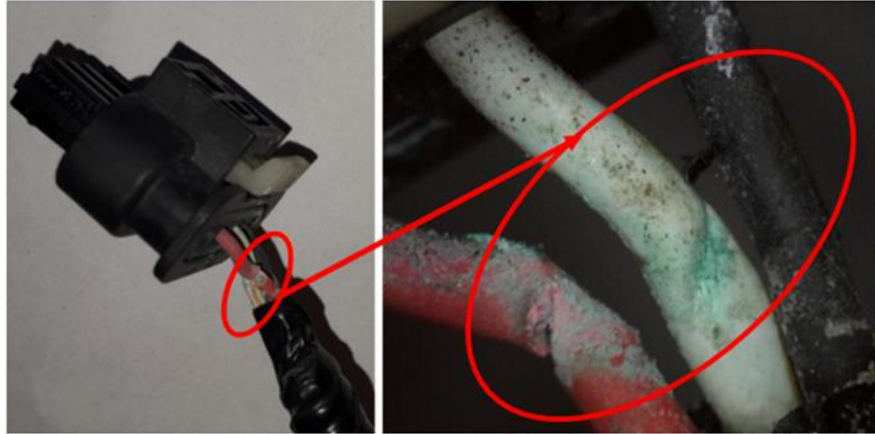
2. Disconnect the AGS to fascia connectors and inspect for damage and corrosion.

Active Grill Shutter Connection Damage/Corrosion
