## STAR ONLINE PUBLICATION

**Case Number:** S2108000161

**Symptom/Vehicle Issue:** Cluster Service Air Suspension Message, DTC C1526-11 Left Rear Ride Height Sensor - Circuit Short To Ground

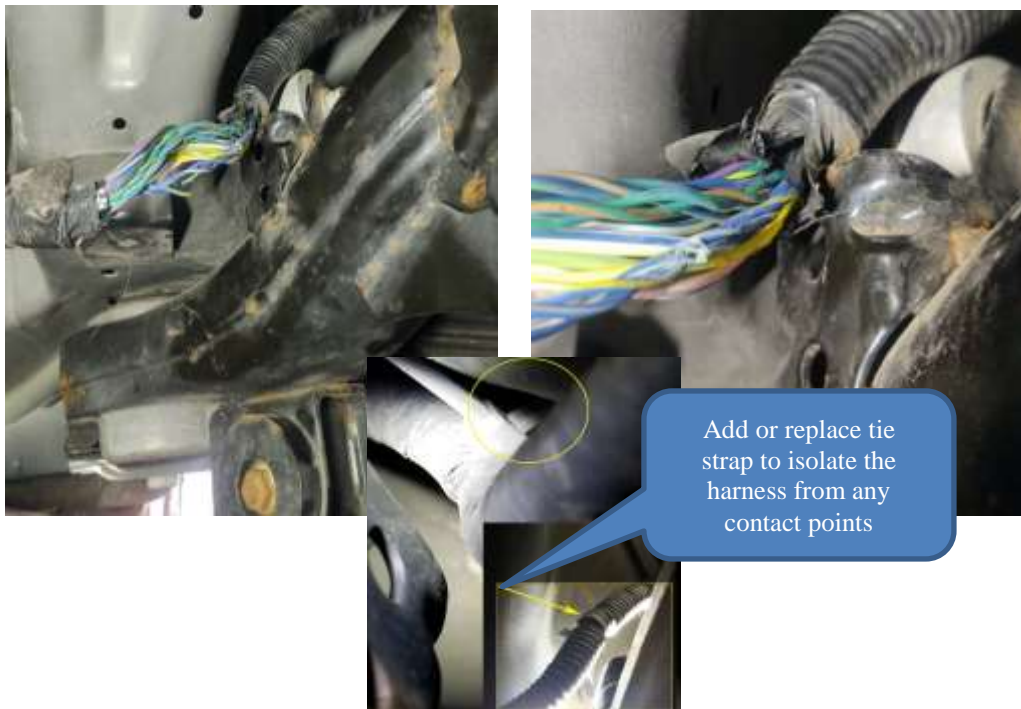
**Customer Complaint/Technician Observation:** Owner complains of a cluster warning message "Service Air Suspension". Technician observed the vehicle is setting DTC C1526-11 Left Rear Ride Height Sensor Circuit Short To Ground.

**Repair Procedure:** Inspection of the harness routing at the rear cradle, fuel tank location. Ensure the harness is secure and not contacting any bracket edges as shown. Repair any harness contact areas and isolate and secure the harness as needed to complete.
