NUMBER: 08-096-21

Intermittent Fails To Crank Or Start

This bulletin includes replacing two starter mounting studs.

2021 (JL) Jeep Wrangler

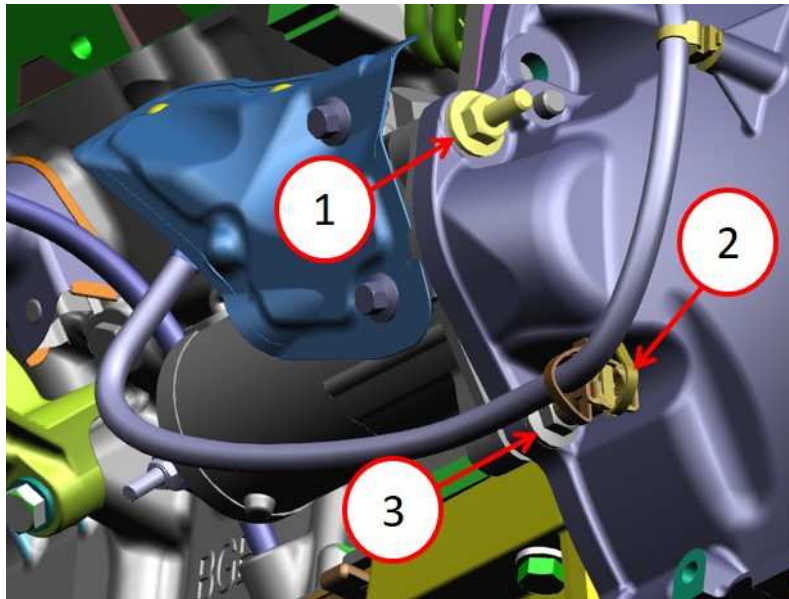
Fig. 1
Starter Mounting Studs

- 1 - Upper Starter Stud
 - 2 - Wire Clip Retainer
 - 3 - Lower Starter Stud
-

1. Disconnect and isolate the negative battery cable. If equipped with an Intelligent Battery Sensor (IBS), disconnect the IBS connector first before disconnecting the negative battery cable.
2. Raise and support the vehicle. Refer to the detailed service procedures available in DealerCONNECT/Service Library under: Service Info>04 - Vehicle Quick Reference / Hoisting / Standard Procedure.
3. Replace the upper mounting stud (Fig. 1) securing the starter. Tighten to 67 N·m (49 ft. lbs.).

4. Carefully remove the wire clip retainer from the bottom starter bolt (Fig. 1) .
5. Replace the lower bolt (Fig. 1) securing the starter. Tighten to 67 N·m (49 ft. lbs.).
6. Install the wire clip retainer on the bottom starter mounting stud (Fig. 1) .
7. Lower the vehicle.
8. Connect the negative battery cable. If equipped with an IBS, connect the IBS connector.
