NUMBER: 08-105-21

GROUP: 08 - Electrical

DATE: June 23, 2021

UAV and UCV Radio Enhancements

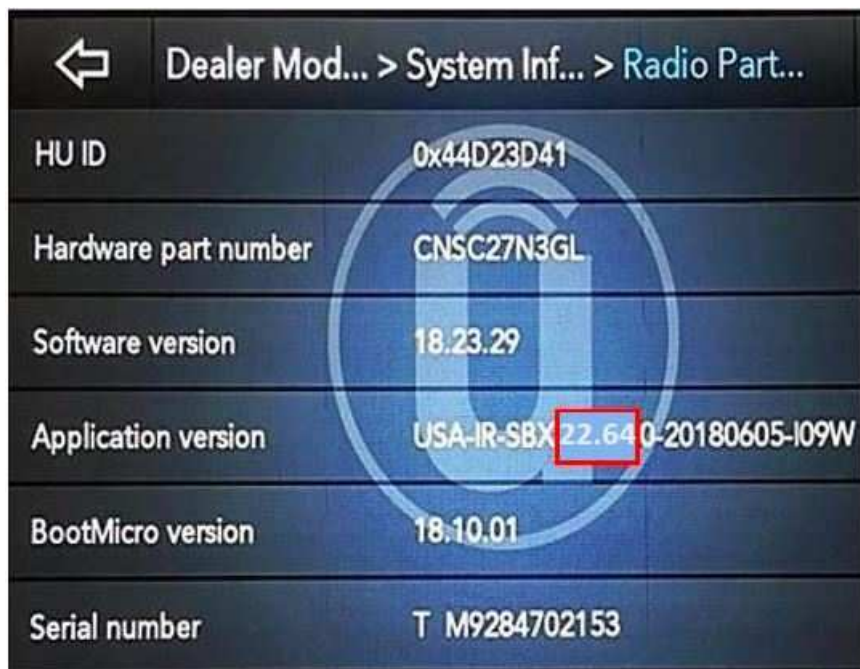
Fig. 1
Radio Software Level Screen

1. Verify the radio software version. Radio must be in Dealer Mode to verify by following these steps:
 - a. Press and hold both lower corners of the display screen, until the Dealer Mode screen appears (approximately seven seconds). Release screen.
 - b. Select "Radio Part Information". The software version will be listed next to "Application Version" (Fig. 1) .

2. What is the radio software level (Application Version) at?
 - 39.5 or higher >>> The radio software is already up to date. Normal diagnostics should be performed.
 - At or above 22.64 and under 39.5 >>> Proceed to [Step 1](#) of the Repair Procedure.

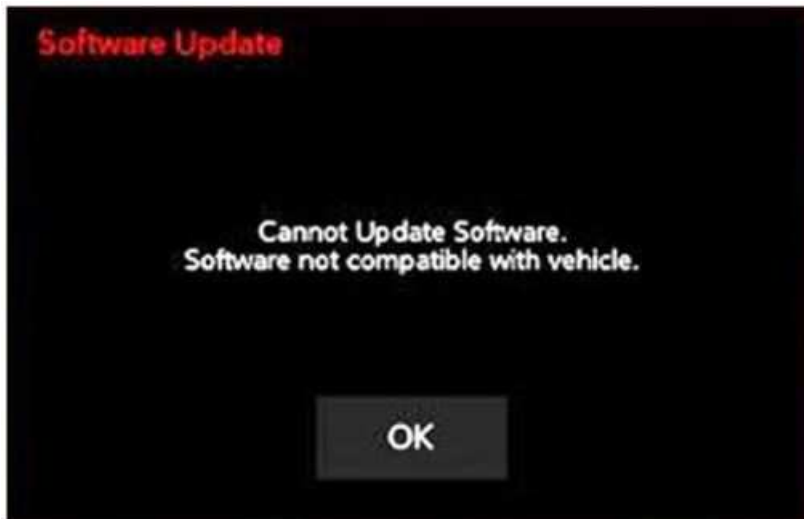
Fig. 5
Software Not Compatible Screen

11. If the screen in (Fig. 5) is displayed, the USB flash drive was not set up correctly. Use a top name brand USB flash drive, like Kingston, create a new USB flash drive and start the update again.

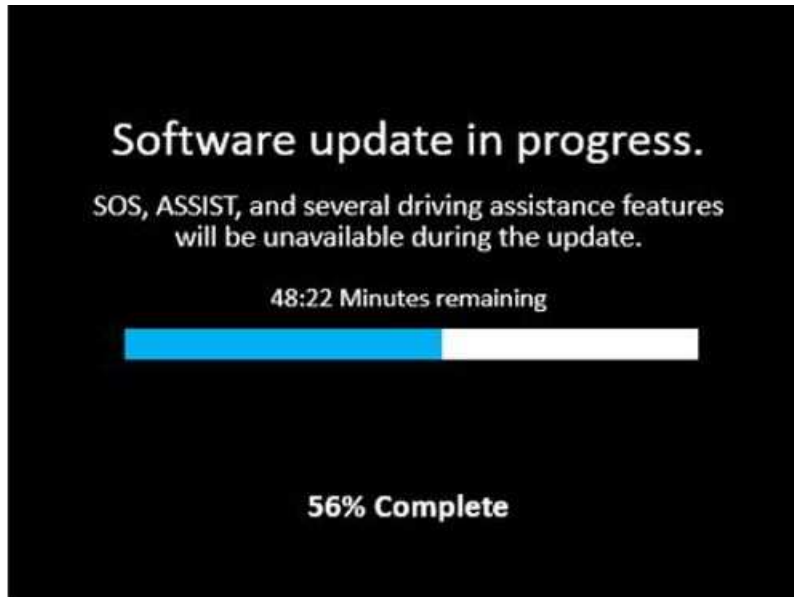
Fig. 9
Software Update In Progress

15. The radio will reboot and the update will begin. The update should only take 25 minutes, the timer on the screen may display the incorrect time remaining, (Fig. 9) .

NOTE: The completion indicator may not reach 100%, even though the software update has been completed. Once the software update has finished, the radio and display screen will turn off.
