NUMBER: 18-010-21 REV. B

GROUP: 18 - Vehicle Performance

Flash: Powertrain Control Module (PCM) Updates

2019	(DJ)	RAM 2500 Pickup
2019	(D2)	RAM 3500 Pickup

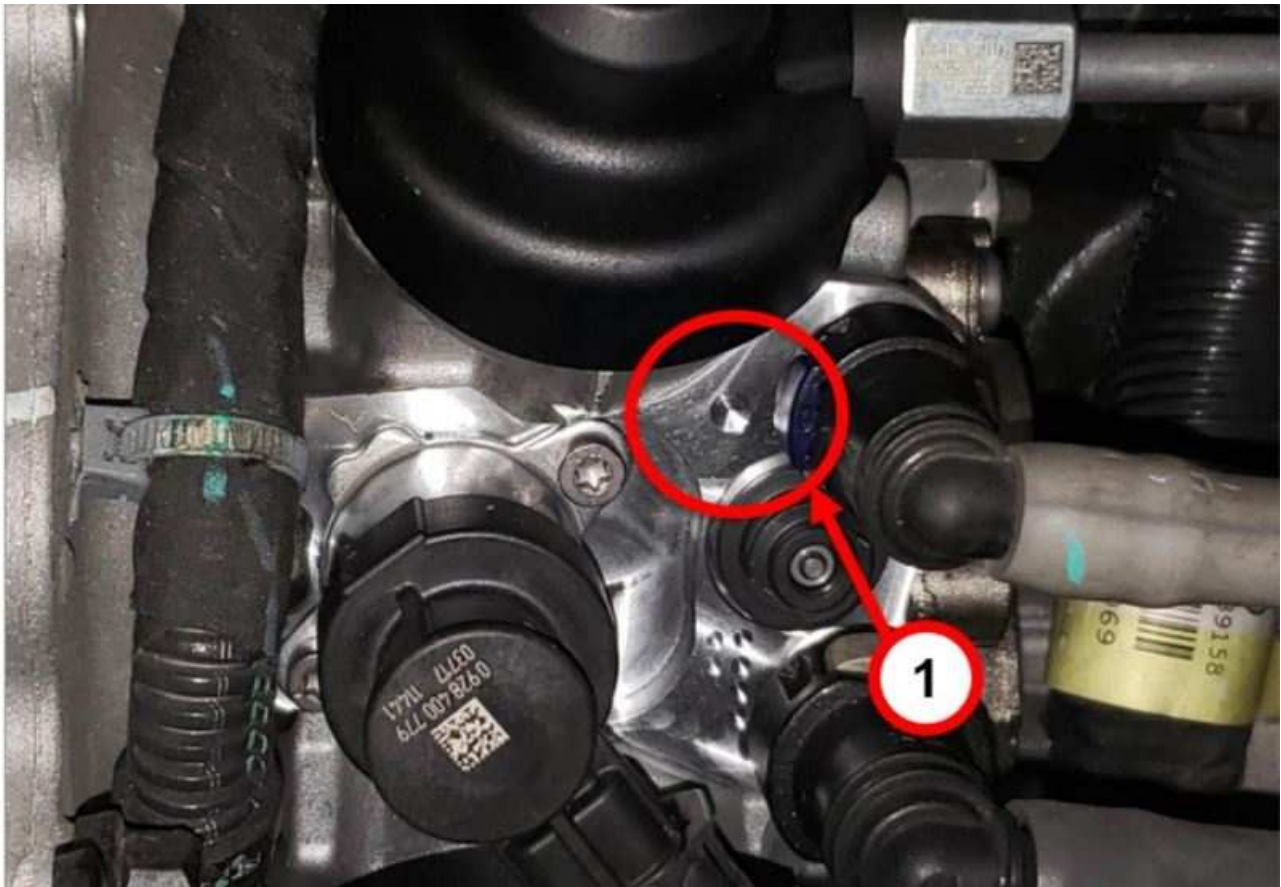
Fig. 1
New Style Symmetrical Cam Design Pump

1. Inspect the fuel injection pump to see which pump the vehicle has:
 - Vehicles with the new style Symmetrical Cam design pump will have one large single dot embossed in the pump housing (Fig. 1) .
 - For vehicles equipped with a Symmetrical Cam pump, choose the calibration labeled Symmetric Cam, or Sym Cam.

1 - One large Single Dot on Housing
