**NUMBER:** 17-001-21

**GROUP:** 17 - Rear Suspension

Rear Shock Eye Can Detach From Shock Body

| 2021 | (VF) | RAM ProMaster |

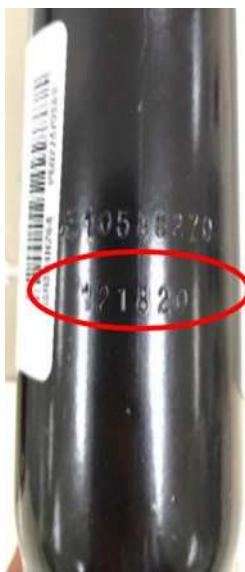
**Fig. 1**  
**Julian Date**

2. Inspect for the Julian date of **121820** (Fig. 1) on both the left and right rear shock absorbers.

3. Did either the left, right, or both rear shock absorber have a Julian date of 121820?
- YES>>> Replace the left, right or both rear shock absorbers. Proceed to [Step 1](#) of the Repair Procedure.
  - NO>>> This bulletin has been completed, use inspection LOP (02-15-15-9E) to close the active RRT.

1. Replace the rear shock absorber. Refer to the detailed service procedures available in DealerCONNECT> Service Library under: Service Info>17 - Rear Suspension / Shock Absorber, Suspension / Removal and Installation.
