NUMBER: 08-107-21

UAM and UCM Radio Enhancements

This bulletin involves updating the radio with the latest available software 23.02.30.19.

2021 (MP) Jeep Compass

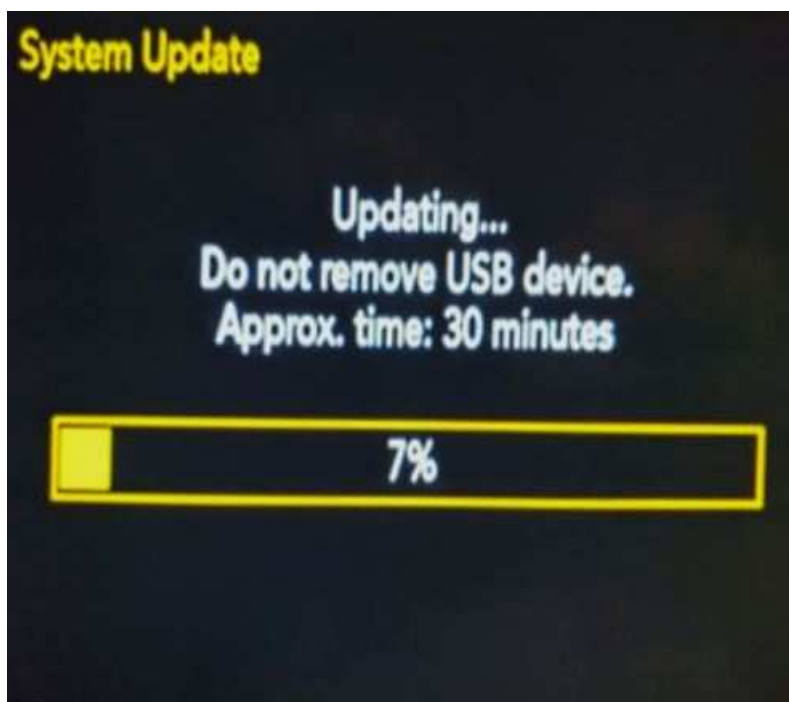
Fig. 2
Percentage Completed Screen

NOTE: There will be a variety of screens displayed throughout the update process. A black screen will appear multiple times in the process for a few minutes ([Fig. 2](#)) .

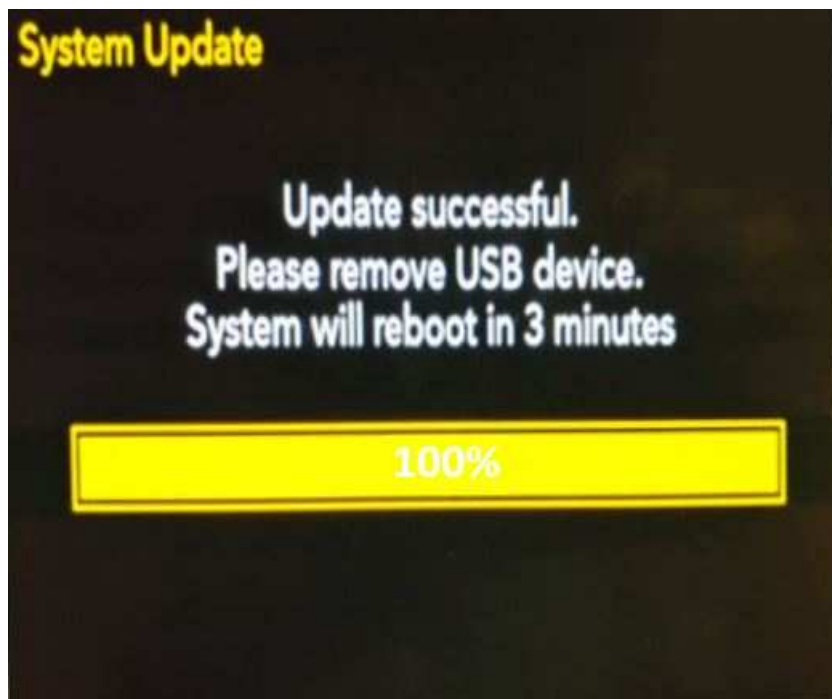
Fig. 3
Update Successful Screen

10. After the update is done the screen will display "Update successful" see (Fig. 3) .
