NUMBER: 14-004-21

GROUP: 14 - Fuel System

Missing Upper Fuel Tank Heat Shield

2021 (WD) Dodge Durango

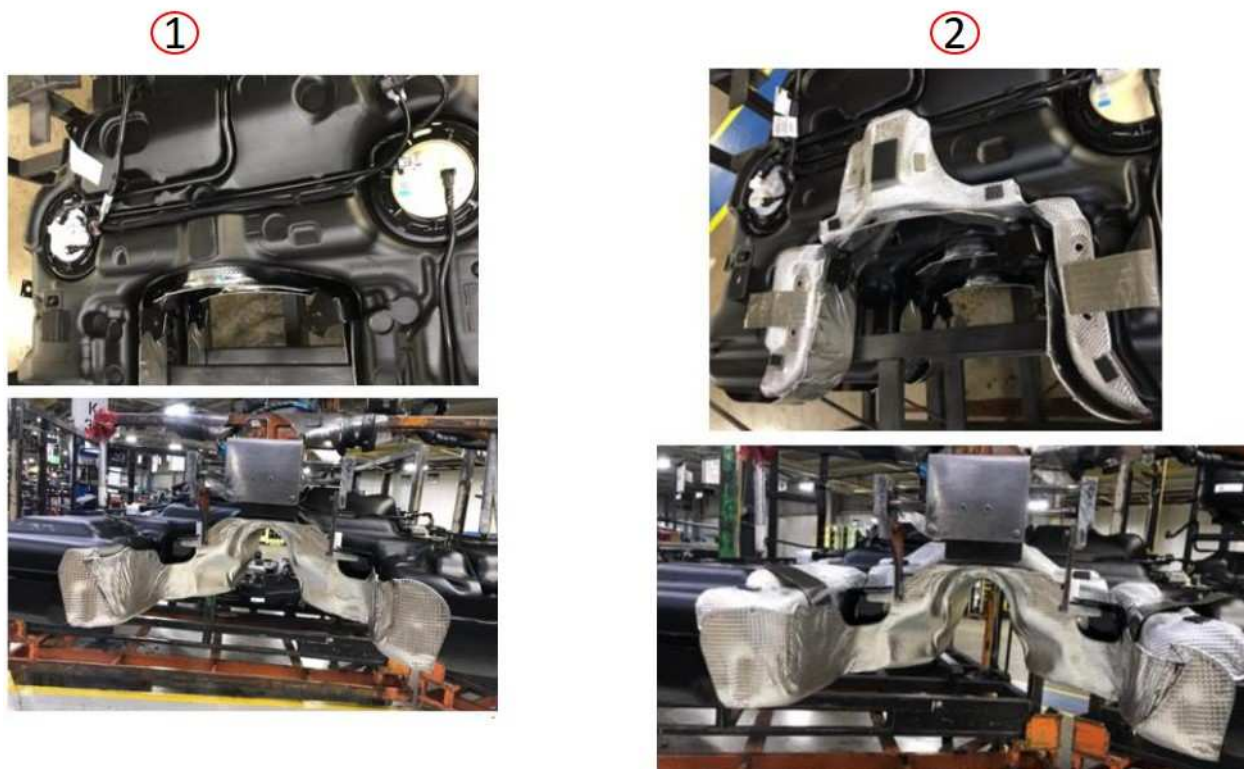
Fig. 1

Customers or technicians may notice that a vehicle that is equipped with a tow n go package that the upper fuel tank shield is missing.

Missing and Correctly Installed Upper Heat Shield

- 1 - Missing Upper Fuel Tank Heat Shield
2 - Correctly Installed Upper Fuel Tank Heat Shield
-

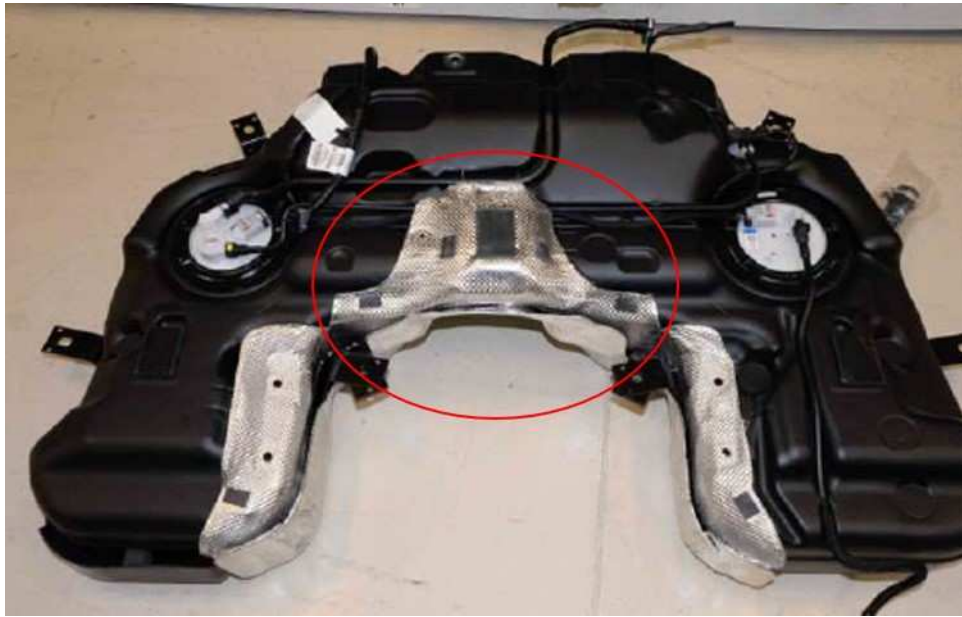
Fig. 2
Correct Heat shield Installed

2. Remove the fuel tank. Refer to the detailed service procedures available in DealerCONNECT/Service Library under: Service Info>14 - Fuel System / Fuel Delivery, Gas / Tank, Fuel / Removal.
3. Install the upper fuel tank heat shield with the new part and secure to the top of the fuel tank (Fig. 2) .
