STAR ONLINE PUBLICATION

Case Number: S2109000004

Symptom/Vehicle Issue: Issue involves overheating, running hot, coolant leaks and related symptoms after a Mopar replacement engine has been installed in the vehicle.

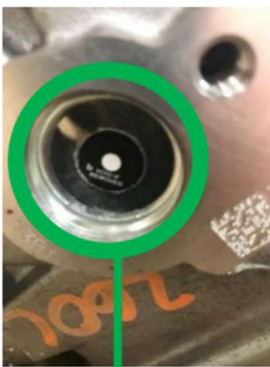
Normal White Sensor

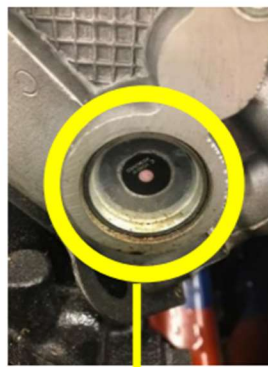
- If heat tabs are white, then the engine has not been over heated.
- If the heat tabs are pink, the engine coolant temp has reached 255°F.
- If the heat tabs are red, the engine coolant temp has exceeded 255°F. This will cause the heads to warp and leak coolant.

Overheated Pink Sensor
255°F Coolant Temp

The cause of the overheat condition must be identified before proceeding. See Warranty Operations Newsletter Vol. 6 Issue 4 article titled “New Heat Tabs on Engines and Intake Manifold Replacement Guidelines” for more information.

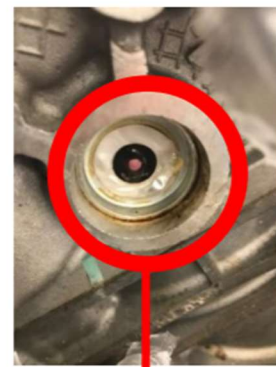
Overheated Red Sensor
+255°F Coolant Temp
