STAR ONLINE PUBLICATION

Case Number: S2123000059

Symptom/Vehicle Issue: Water Leak At Headliner Near Driver Microphone

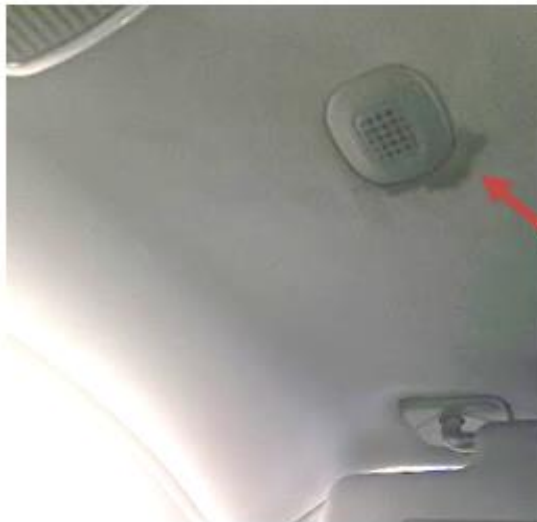
Customer Complaint/Technician Observation: Customer notices water at the headliner mounted microphone (fig 1).

Water Leak

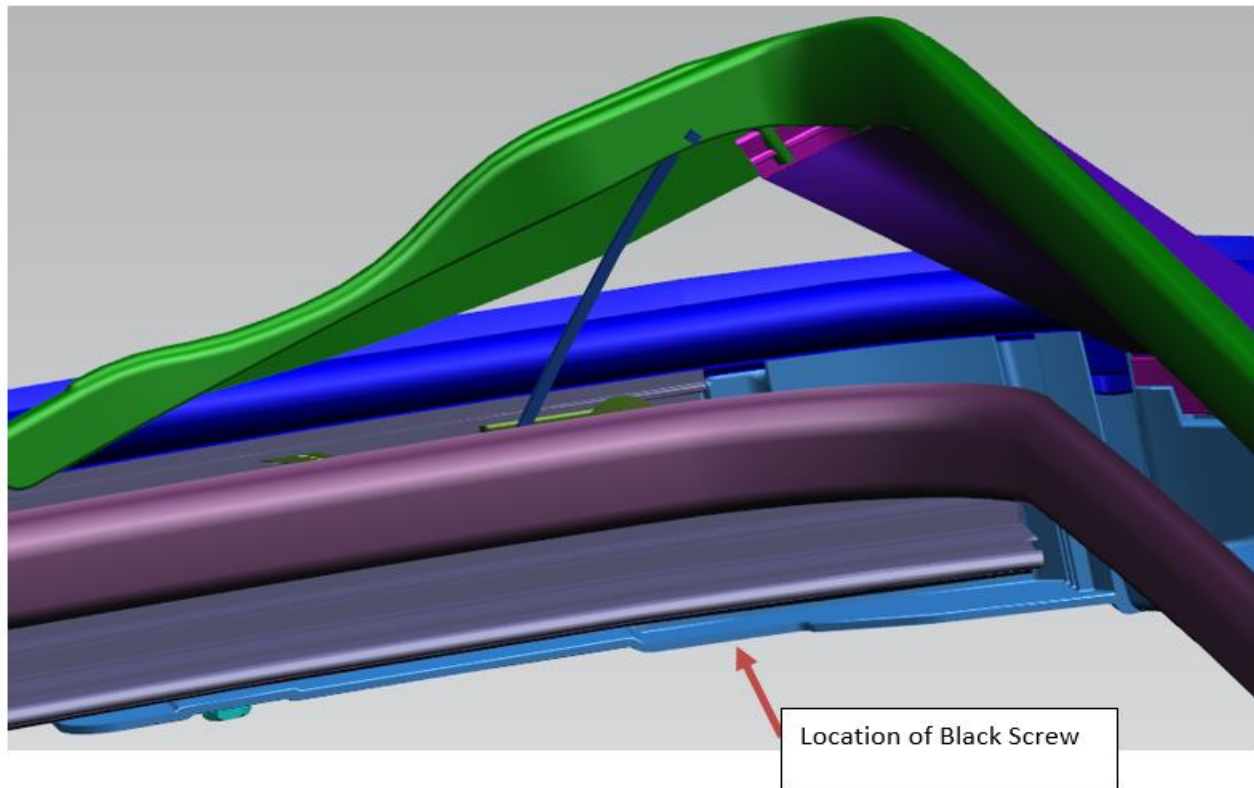
Discussion: Water found in the microphone area may be due to a loose fastener on the sunroof frame. Fig 2 shows the approximate area of the screw. Perform a water test at the screw location to verify the leak is from this location. Use a cup or bottle to apply the water to the screw while looking for water entering below the headliner from this location. It will be necessary to pull the headliner down and use a light to inspect for water. If water is found coming into the vehicle proceed with the below information.

Driver front corner of dual pane sunroof frame viewed from the center of the sunroof opening

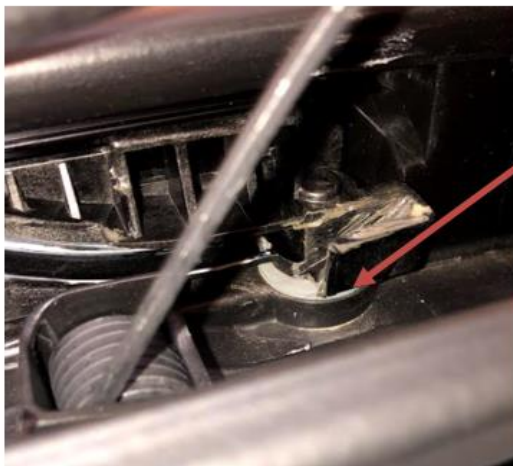
Fig 3

Use water bottle and pour water over white/grey washer

Locate the screw in Fig 3. The screw is in the drain trough forward of the air deflector spring. Lower the headliner (should not be necessary to remove it) to gain access to the screw head T25 size. Tighten the black screw to 26 in lbs +/- 4 (3 +/- 0.5 Nm). Once tightened perform a follow up water test using a cup or bottle to apply water directly on the black sunroof screw in the drain trough in the area to verify the leak is no longer present.

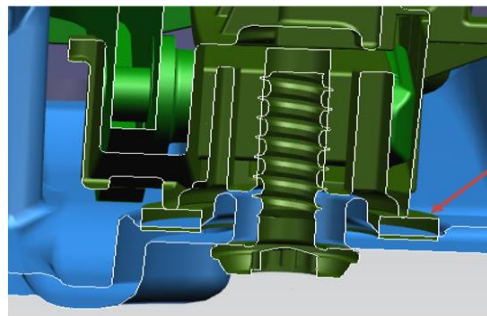
Cross section of black screw joint

White/grey washer
