STAR ONLINE PUBLICATION

Case Number: S2018000007 REV. D

Symptom/Vehicle Issue: Diagnostic Trouble Code (DTC) P0299 – Turbocharger Underboost Additional Diagnostics

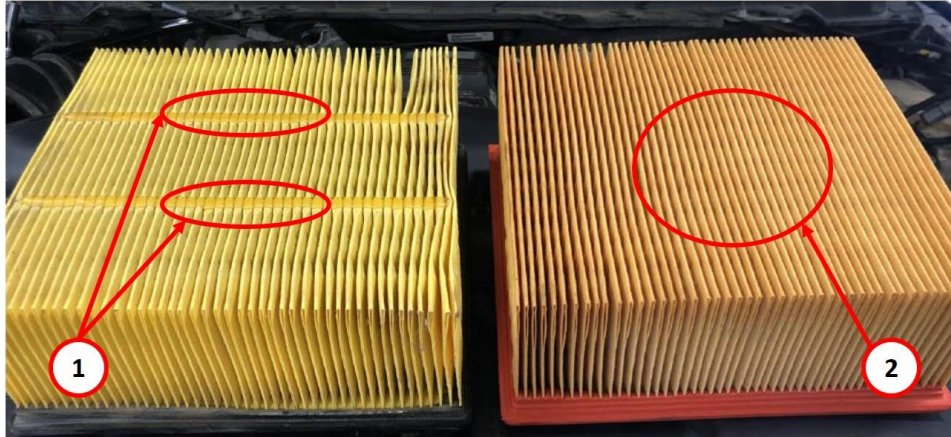
Figure 1

1. Remove, and inspect the engine air filter. Ensure that the air filter is clean, and not restricted.
2. Inspect the bottom of the air filter to see if it utilizes glue strips to separate the pleats. Newer design OEM replacement air filters, and some aftermarket filters utilize glue strips to separate the pleats. Please see ([Figure 1](#)). There have been reports that filters using this design can potentially cause this DTC. If the air filter installed on the vehicle utilizes these glue strips, swap it with one that is not equipped with them, and retest.

1. Glue Strips
2. No Glue Strips

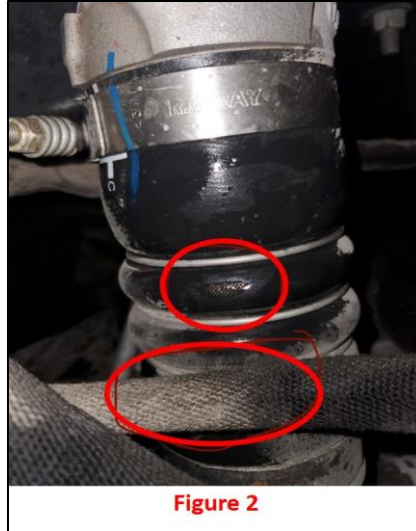
Figure 2

3. Ensure that the Charge Air Cooler (CAC) system is properly pressure tested per the steps outlined in Service Library Service Information Section 09 – Engine, 6.7L Diesel > Turbocharger System > Diagnosis and Testing – Leaks. While performing the CAC leak testing, pay close attention to the CAC boot connected to the turbo outlet for leaks caused by the wire harness rubbing through the boot. Please see (Figure 2).

4. If the boot is found damaged, replace as necessary, and retest the CAC system for any additional leaks. Repair as necessary.

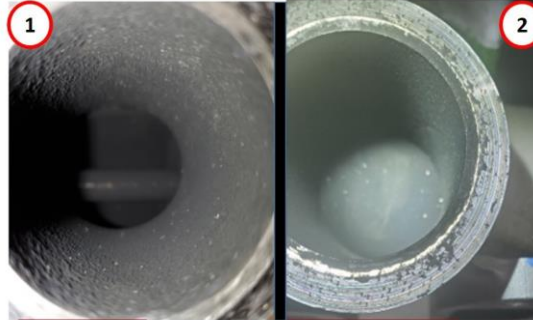
Figure 3

NOTE: EGR valves with a rotated seat may also set DTC P0401 – EGR System Performance along with the P0299 DTC.

5. Remove the EGR Crossover tube from the EGR valve, and inspect the EGR inlet to see if there are signs that the valve internal seat has begun to rotate. Please see (Figure 3). The EGR internal shaft should be completely visible when looking into the crossover tube inlet.

1. Healthy part
2. EGR with rotated seat

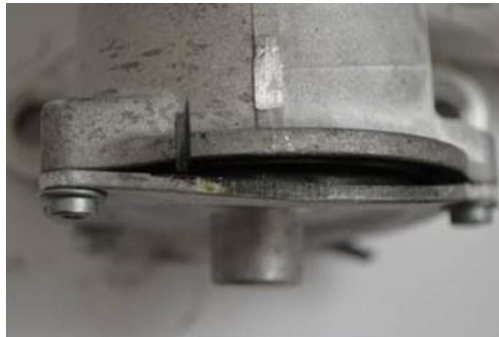
Figure 4

6. Thoroughly inspect the EGR valve end cap for signs of leaks (Figure 4). If found to be leaking, replace the EGR valve.
