**NUMBER:** 08-109-21

3.6L Check Engine Light and Rough Running Engine

**OVERVIEW:**

2021 (DT) RAM 1500 Pickup

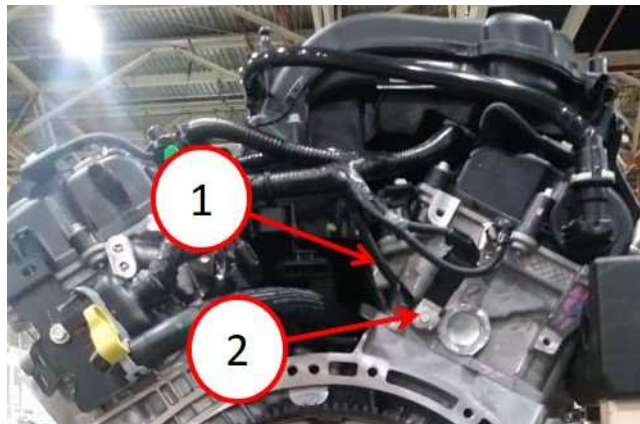
Fig. 1

**Engine Ground Wiring Harness And Eyelet Bolt**

- 1 - Engine Ground Wiring Harness To Cut
- 2 - Engine Ground Eyelet Bolt

1. Remove the engine cover. Refer to the detailed service procedures available in DealerCONNECT/Service Library under: 09 - Engine, 3.6L / cover, Engine / Removal.
2. Remove the upper intake manifold. Refer to the detailed service procedures available in DealerCONNECT/Service Library under: 09 - Engine, 3.6L / Manifolds / Manifold, Intake / Removal.
3. Remove the lower intake manifold. Refer to the detailed service procedures available in DealerCONNECT/Service Library under: 09 - Engine, 3.6L / Manifolds / Manifold, Intake / Removal.
4. Remove right ground bolt (**G927A**) and engine ground eyelet (**Fig. 1**) from the engine.

5. Using a wire cutting tool, cut engine ground eyelet from engine ground wiring harness (**Fig. 1**) .

11. Using Tesa tape, wrap seven wires to engine ground wiring harness.
12. Install the ground eyelet and ground bolt on engine (Fig. 1) . Tighten ground bolt to 20 N·m (15 ft. lbs.).
13. Install the lower intake manifold. Refer to the detailed service procedures available in DealerCONNECT/Service Library under: 09 - Engine, 3.6L / Manifolds / Manifold, Intake / Installation.
14. Install the upper intake manifold. Refer to the detailed service procedures available in DealerCONNECT/Service Library under: 09 - Engine, 3.6L / Manifolds / Manifold, Intake / Installation.
