NUMBER: 08-111-21

3.6L Check Engine Light and Rough Running Engine

2021	(JL)	Jeep Wrangler
2021	(JT)	Jeep Gladiator

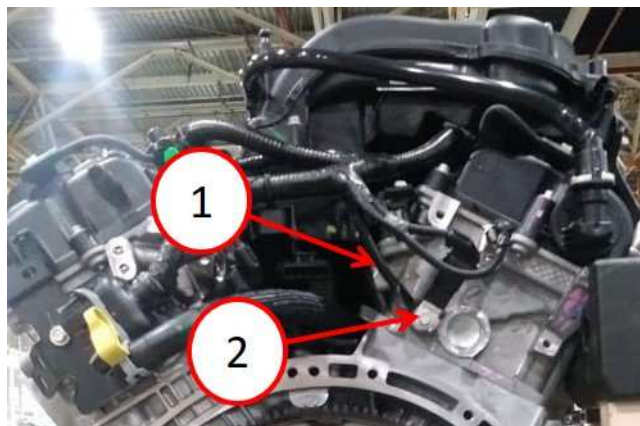
Fig. 1
Engine Ground Wiring Harness And Eyelet Bolt

Customers may experience a Malfunction Indicator Lamp (MIL) illumination. Upon further investigation the technician may find one or more of the following Diagnostic Trouble Codes (DTCs) have been set:

- 1 - Engine Ground Wiring Harness To Cut
2 - Engine Ground Eyelet Bolt

1. Open the hood.
2. Remove the upper intake manifold. Refer to the detailed service procedures available in DealerCONNECT/Service Library under: 09 - Engine, 3.6L / Manifolds / Manifold, Intake / Removal.
3. Remove the lower intake manifold. Refer to the detailed service procedures available in DealerCONNECT/Service Library under: 09 - Engine, 3.6L / Manifolds / Manifold, Intake / Removal.
4. Remove the right ground bolt (**G927A**) and engine ground eyelet (**Fig. 1**) from engine.

5. Using a wire cutting tool, cut engine ground eyelet from engine ground wiring harness (**Fig. 1**) .

11. Using Tesa tape, wrap seven wires to engine ground wiring harness.
12. Install the ground eyelet and ground bolt on engine (Fig. 1) . Tighten ground bolt to 20 N·m (15 ft. lbs.).
13. Install the lower intake manifold. Refer to the detailed service procedures available in DealerCONNECT/Service Library under: 09 - Engine, 3.6L / Manifolds / Manifold, Intake / Installation.
14. Install the upper intake manifold. Refer to the detailed service procedures available in DealerCONNECT/Service Library under: 09 - Engine, 3.6L / Manifolds / Manifold, Intake / Installation.
15. Close the hood.
16. Clear any DTCs that may have been set.
