SUBJECT:

Tonneau Cover Broken Strap

This bulletin involves repairing broken tri-fold tonneau cover retention straps.

2019 - 2021	(DT)	RAM 1500 Pickup
2019 - 2021	(DS)	RAM 1500 Pickup
2019 - 2021	(DJ)	RAM 2500 Pickup
2019 - 2021	(D2)	RAM 3500 Pickup

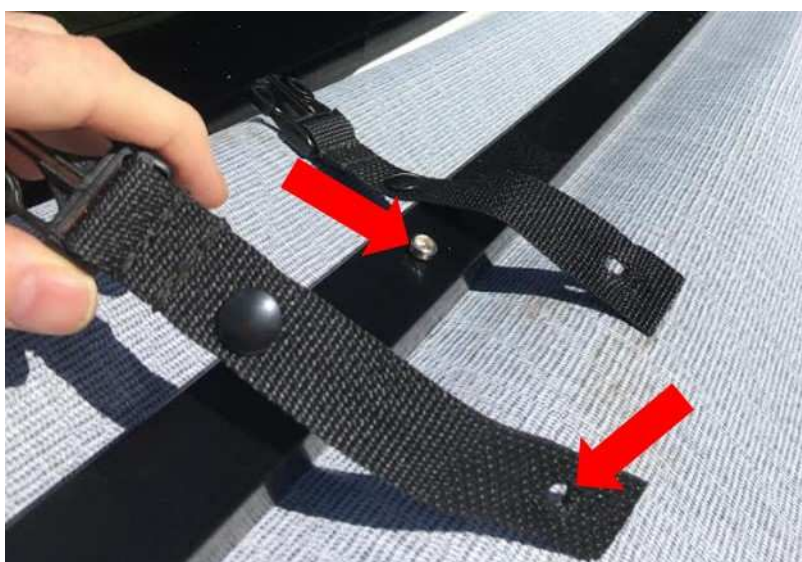
- One or more of the tri-fold tonneau cover retention straps have torn off the frame assembly (Fig. 1) .

Fig. 1
Torn Tonneau Retention Straps

1. Replace the retention strap and rivet. Using a 3.17 mm (1/8 in.) drill bit, drill out the old rivet.
2. Using a rivet gun, secure the new retention strap with supplied washer placed between the rivet head and the retention strap.
