Flash: Instrument Panel Cluster (IPC) Updates

This bulletin involves reprogramming the IPC with the latest available software.

2020 - 2021 (BV) Jeep Renegade

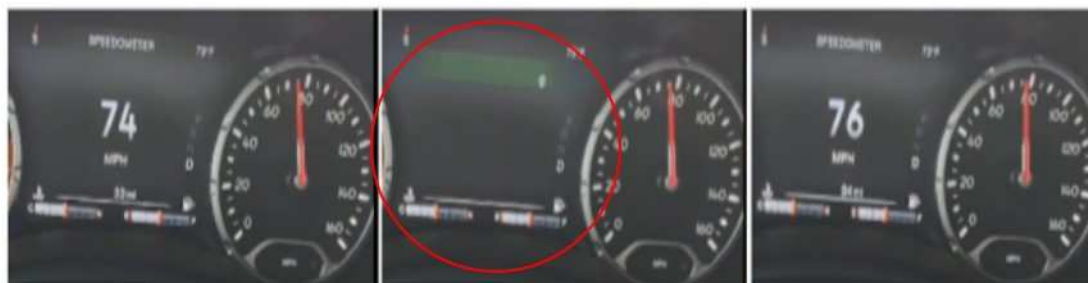
- The Electronic Vehicle Information Center (EVIC) screen goes blank and only displays a green bar at the top at 120 kph (75 mph) (Fig. 1) .

Fig. 1
Green Bar Appearing

1. Reprogram the IPC with the latest software. Detailed instructions for flashing control modules using the wiTECH Diagnostic Application are available by selecting the application's "HELP" tab.
2. Disconnect the wiTECH pod.
3. Cycle the ignition 'off' and allow vehicle to go to sleep for two minutes.
4. Reconnect the wiTECH pod.
5. Clear all DTCs that may have been set in any module due to reprogramming. The wiTECH application will automatically present all DTCs after the flash and allow them to be cleared.
