## STAR ONLINE PUBLICATION

**Case Number:** S1518000022 (REV.B)

**Symptom/Vehicle Issue:** Malfunction Indicator Lamp (MIL) Illumination And/OR Battery Drain. Diagnostic Trouble Codes (DTC's) P2609 – Intake Air Heater System Performance set.

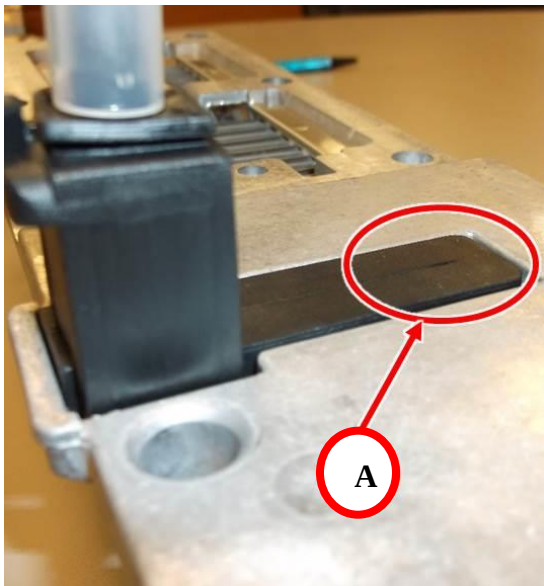
**Figure 1**

1. Inspect the grid heater power terminal located on the intake manifold cover for the plastic over-mold being deformed as well as the power feed cable for signs of terminal sealant flow from the terminal sleeve (See Figure 1 and 2).

(a.) Good part. No deformation

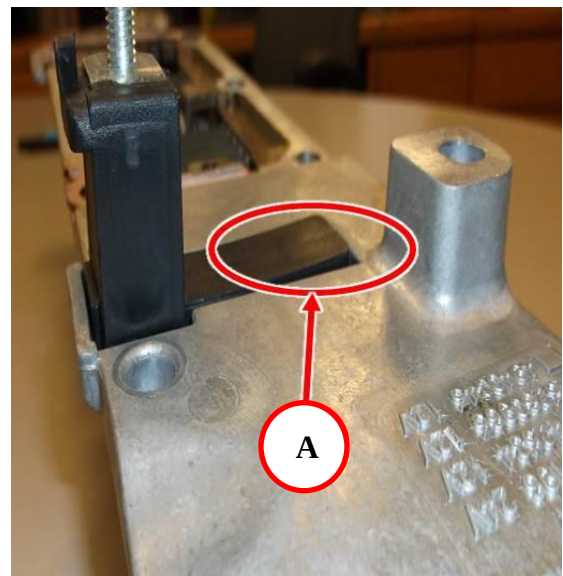
**Figure 2**

(a.) Failed part. Slight lifting of plastic

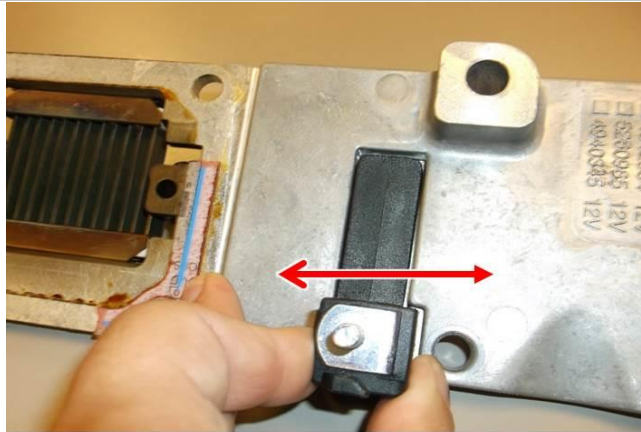
### Figure 3

2. Check to see if the grid heater power terminal can be moved by hand (See Figure 3).

There should be NO movement of the terminal back and forth.

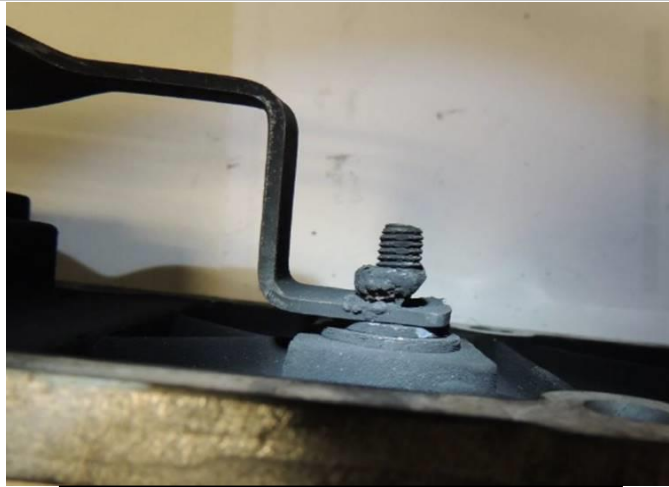
**Figure 4**

The most common cause of this DTC, and condition, is the Intake Heater Grid relay sticking on for an extended period of time. When the relay sticks on, it can overheat the heater element leading to the loosening of the retaining nut on the underside of the intake manifold cover plate. This leads to arching of the connection which will eventually cut through the stud causing it to drop into the intake manifold, and into the engine.

3. Was excess movement found in the terminal?  
Yes>>> Proceed to step 4  
No>>> The heater grid is not affected and this SOL Publication no longer applies.  
Follow normal published diagnostics for the DTCs set
4. Remove the grid heater assembly and inspect the bolt on the bus bar for signs of arching and damage. See (**Figure 4**)

If damage to the grid heater element was found, the grid heater relay has most likely stuck on recently causing failure of the grid heater element. Replace the intake grid heater assembly and grid heater relay as a set under normal warranty repair guidelines for relay replacement.
