### STAR ONLINE PUBLICATION

**Case Number:** S2118000007

**Symptom/Vehicle Issue**: MIL Lamp On DTC P1CEA BOOST SIDE EVAP PURGE SYSTEM PERFORMANCE

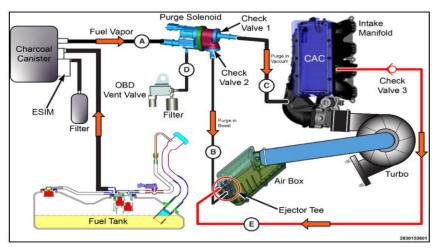
Figure 1 EVAP System for 2.0L engines.

**Repair Procedure:** See figure 1 and figure 2 for proper connection of the lines. Before proceeding on disconnecting the vacuum line for the Ejector Tee (the line that connects to the Purge Solenoid at the outer end), check to determine if the lines are properly connected to the Purge Solenoid port and the CAC/Intake Manifold port.

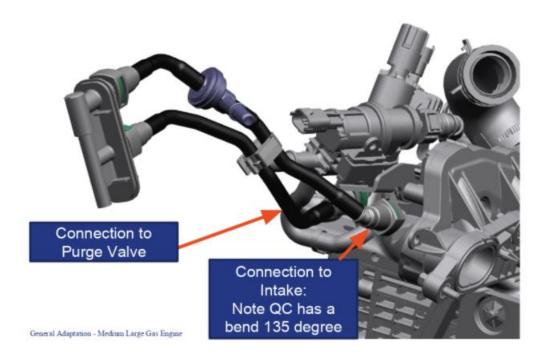
Figure 2
Lines connected to Air Box Ejector Tees and Purge Valve Port and CAC/Intake
Manifold Port.

If the lines are properly installed to the Purge Valve and the CAC/Intake Manifold Port, then continue performing Service Diagnostics for P1CEA.
