STAR ONLINE PUBLICATION

Case Number: S2018000007 REV. C

Symptom/Vehicle Issue: Diagnostic Trouble Code (DTC) P0299 – Turbocharger Underboost Additional Diagnostics

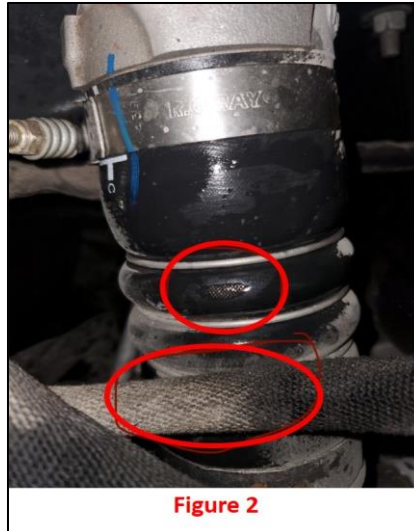
Figure 2

3. Ensure that the Charge Air Cooler (CAC) system is properly pressure tested per the steps outlined in Service Library Service Information Section 09 – Engine, 6.7L Diesel > Turbocharger System > Diagnosis and Testing – Leaks. While performing the CAC leak testing, pay close attention to the CAC boot connected to the turbo outlet for leaks caused by the wire harness rubbing through the boot. Please see (Figure 2).

4. If the boot is found damaged, replace as necessary, and retest the CAC system for any additional leaks. Repair as necessary.

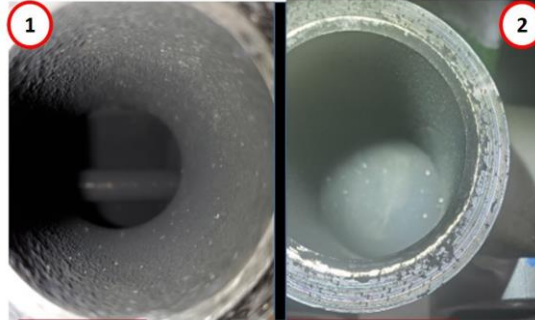
Figure 3

NOTE: EGR valves with a rotated seat may also set DTC P0401 – EGR System Performance along with the P0299 DTC.

5. Remove the EGR Crossover tube from the EGR valve, and inspect the EGR inlet to see if there are signs that the valve internal seat has begun to rotate. Please see (Figure 3). The EGR internal shaft should be completely visible when looking into the crossover tube inlet.

1. Healthy part
2. EGR with rotated seat
