STAR ONLINE PUBLICATION

Case Number: S2124000008

Symptom/Vehicle Issue: Poor Airflow From 2nd Or 3rd Row Vent Outlets

WL 7574 Battery Cover Installation Process

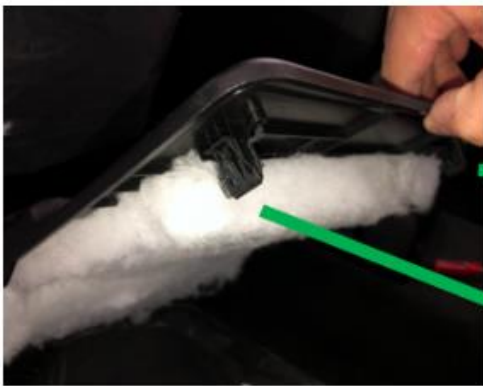
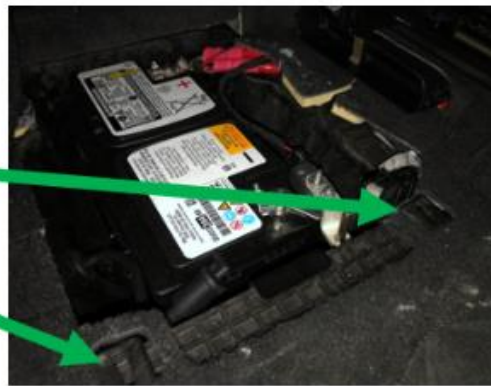
Tabs needs to be precisely aligned with the openings

Snap in two lower tabs by locating the tabs on the openings and then pressing downwards to fully secure the battery cover

Press downwards on the two tabs until an audible or tactile "click" is heard / felt

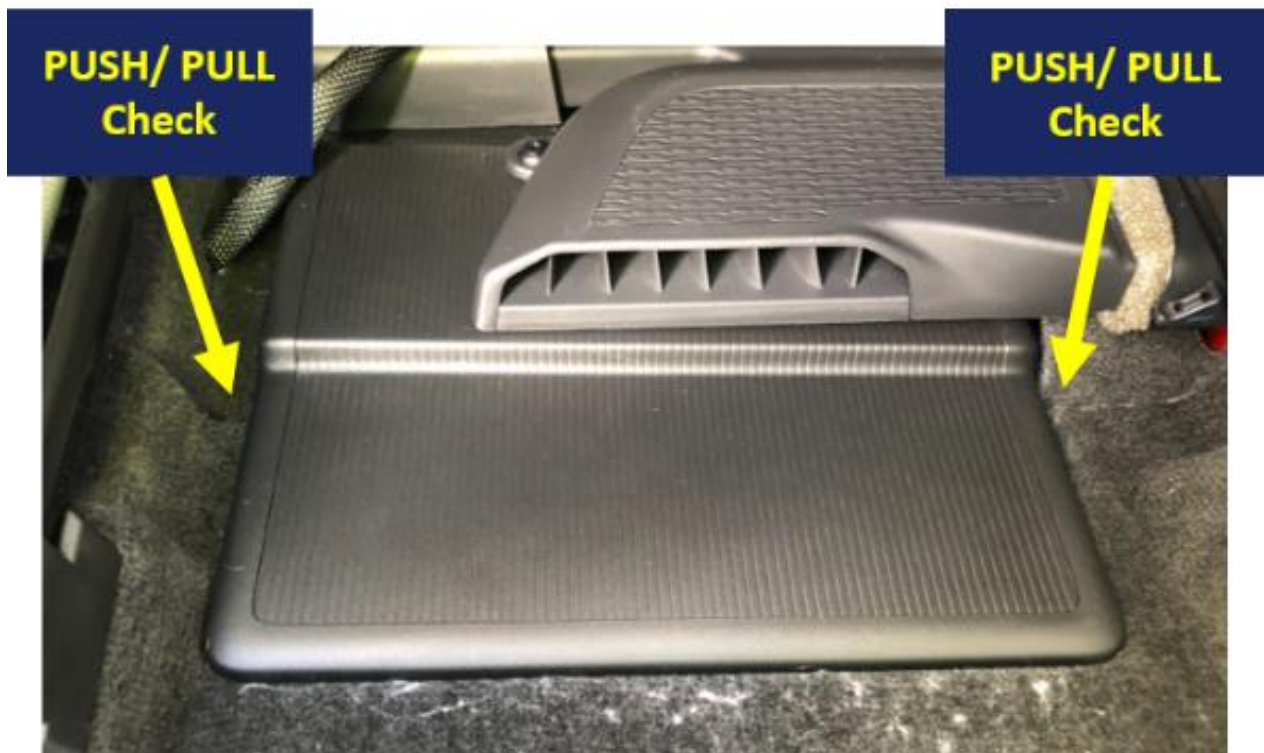
Inspect both battery cover “fingers” using a push/pull check to verify that battery cover does not show gap with light pressure

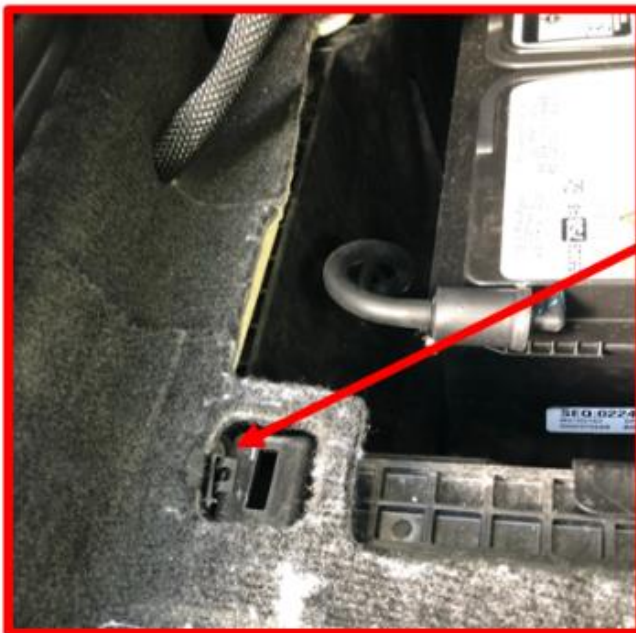
Bad condition: Misaligned battery tab, battery cover tab broken off

Broken battery cover tab and clip

Need to recover loose battery tab and clip pieces that have broken off and replace battery cover.

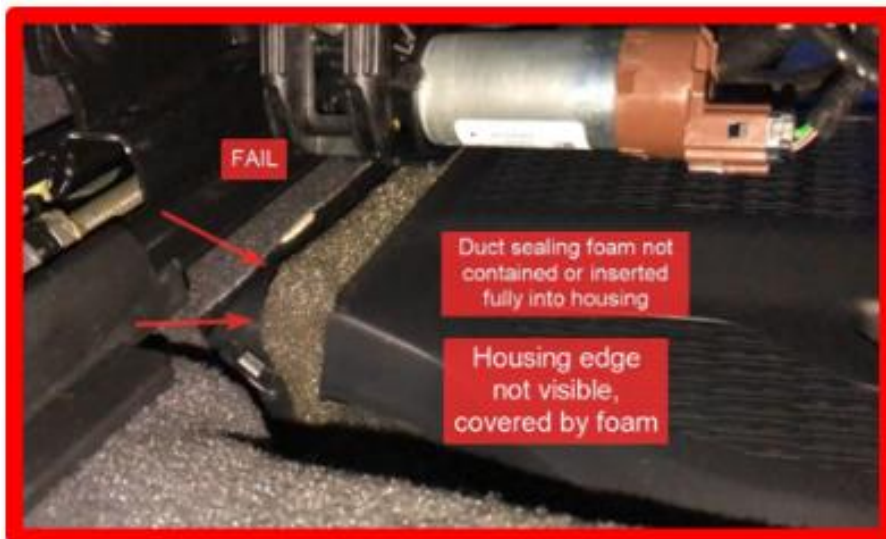
Inboard side foam: misaligned BAD

Insert inboard side of duct assembly into HVAC opening

Ensure that all foam is encapsulated within the opening

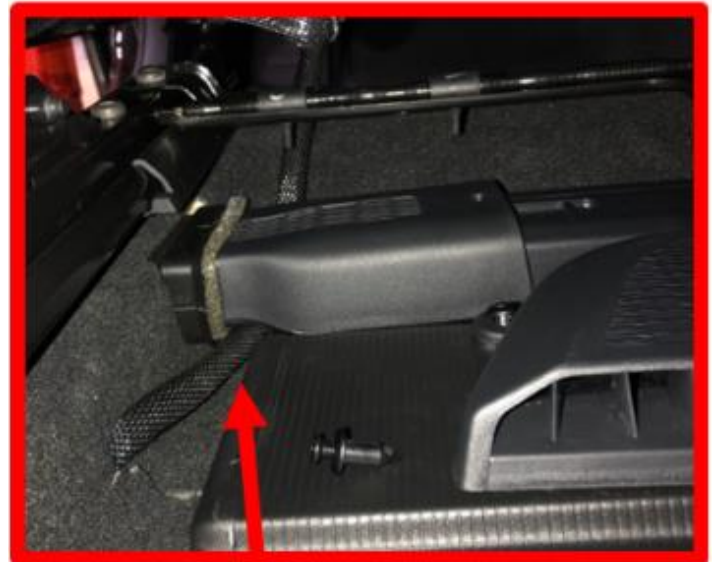
Telescoping duct: BAD

- Telescoping duct is not fully telescoped outwards and also not in 2nd detent position
- Foam is showing and not fully encapsulated within HVAC opening
- Gap between telescoping duct and HVAC opening
- Wire harness is underneath duct

Extend telescoping duct fully to 2nd detent position to the outboard duct opening

Ensure that the foam is not visible when the telescoping duct is fully extended

Ensure that the wiring harness goes over the telescoping duct

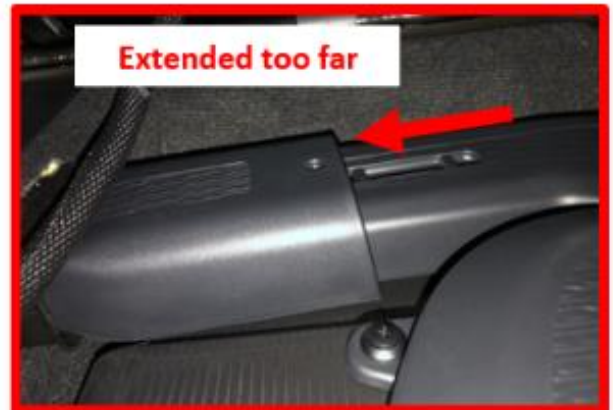
Telescoping duct extension: BAD

- Telescoping duct extended too far past 2nd detent
- Needs to be located exactly in 2nd detent where tactile "click" is felt

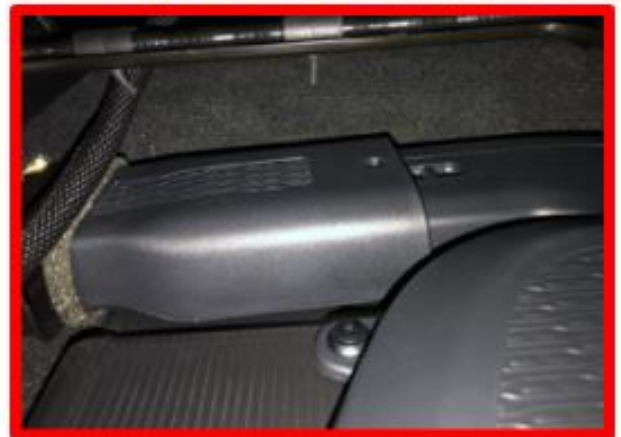
Telescoping duct extension: BAD

- Telescoping duct not extended far enough – before 2nd detent
