NUMBER: 08-081-21

UGG and UGM Connectivity Activation

This bulletin involves updating the radio software level to 23.02.87.10.

2019 - 2021 (BV) Jeep Renegade

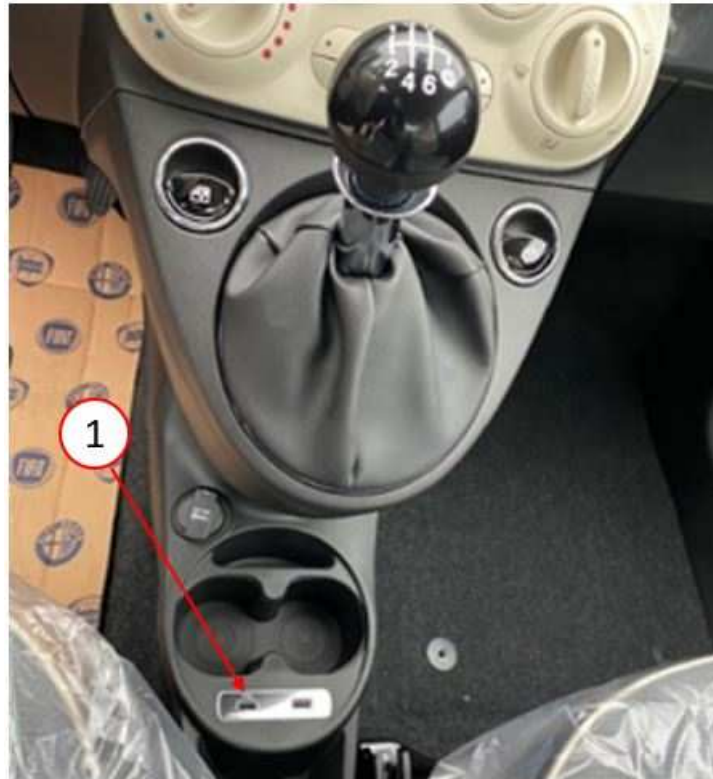
Fig. 5
USB Port Location

1 - USB port for radio update.

7. Insert the correct USB flash drive with new software into USB port (Fig. 5) .

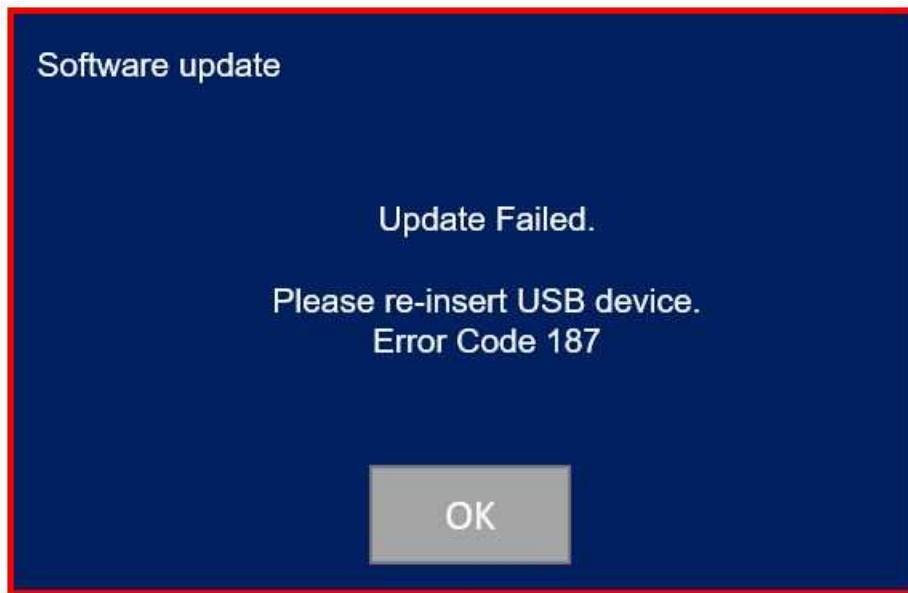
Fig. 7
Error Message Display

11. If you see during reflash on the screen any error message like “Error code 187, 255 or 260” there is a reading problem with USB stick. Just reinsert USB and if it repeats use another USB stick ([Fig. 7](#)) .
