STAR ONLINE PUBLICATION

Case Number: S2123000033

Symptom/Vehicle Issue: Underbody Ticking Noise That Increases With Vehicle Speed

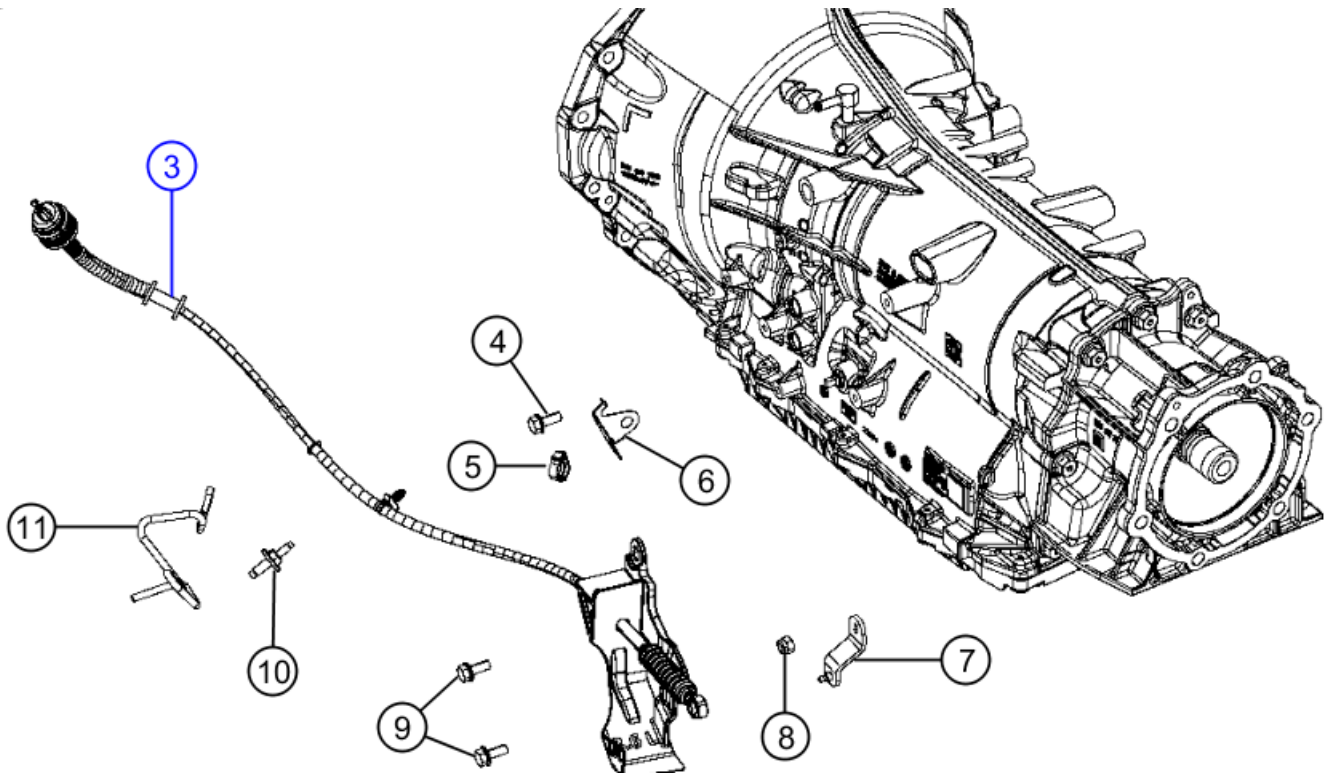
Fig 1
Item 3- gear shift cable MPR cable

Discussion: The ticking noise maybe caused by the transmission manual park release cable (fig 1) rubbing on the prop shaft. The condition occurs when the barrel clip (PN: 68048877AA) is open and not retaining the shift cable to the transmission bracket or the barrel clip is shy.

- 1) Bring vehicle to Hoist
- 2) Locate the Manual Park Release (MPR) cable secured to the transmission lever on the left side of the transmission.
- 3) Follow the cable up towards the front of the vehicle and inspect if MPR cable is rubbing on the front prop shaft.
- 4) If Yes, Inspect the MPR cable for any damage.

5) If damage is present (Fraying, cuts, kinks, etc.) MPR cable (PN: 68507309AA current) must be replaced.
