NUMBER: 23-018-21

Forward Facing Camera Bracket Delaminates From Windshield

2021 (DT) RAM 1500 Pickup

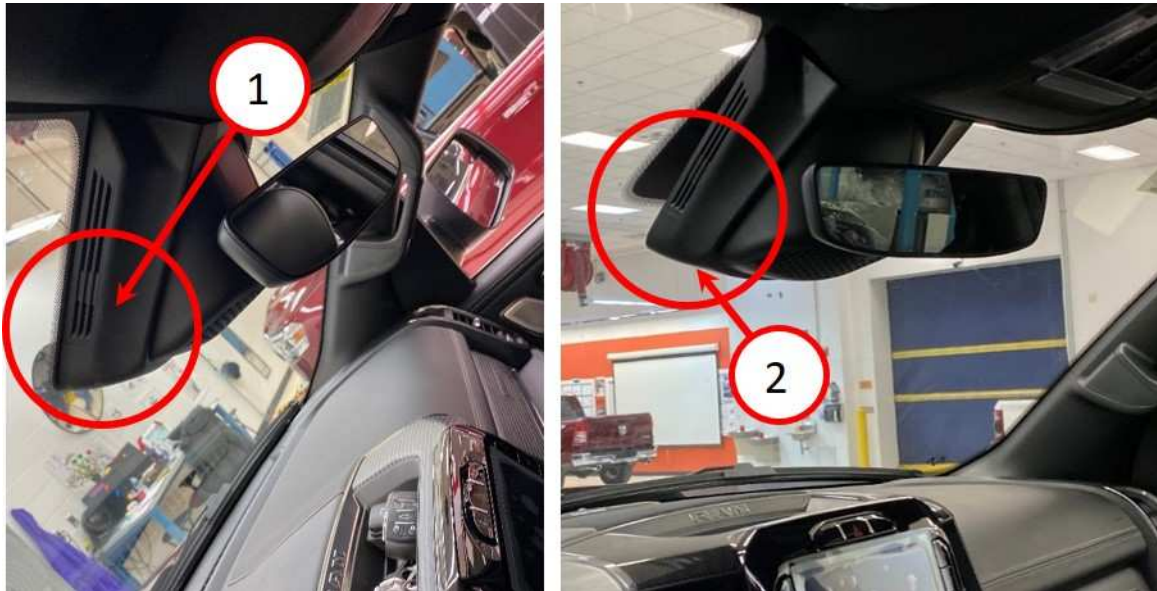
1. Inspect the IRCM bracket by removing the sensor cover and inserting a feeler gauge in between the IRCM bracket and the windshield (Fig. 1) .

Fig. 1
Failure As Seen By Customer

- 1 - Example of Good IRCM bracket Adhesion.
2 - Example of Bad IRCM bracket Adhesion.

1. Replace the windshield. Refer to the detailed service procedures available in DealerCONNECT> Service Library under: Service Info>23 - Body / Stationary Glass / Windshield / Removal and Installation.

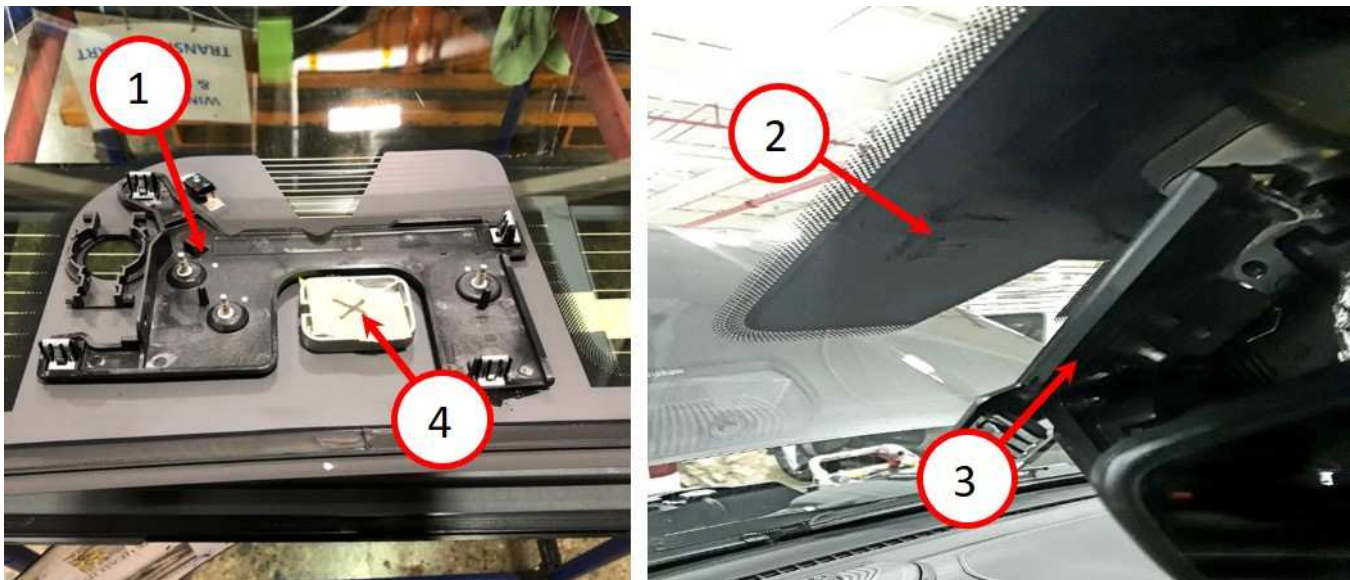
2. Was the adhesive soft/uncured and/or the IRCM bracket unsecured (Fig. 2) ?
- YES>>> Proceed to [Step 1](#) of the Repair Procedure.
 - NO>>> This bulletin has been completed, use LOP (23-30-50-9G) to close the active RRT.

Fig. 2
Failure As Seen After Cover Removal

- 1 - IRCM Bracket (Good Example Shown)
2 - Uncured/Soft Adhesive
3 - Loose IRCM Bracket (Bad Example Shown)
4 - Mirror Button

NOTE: The IRCM bracket is not a serviceable part due to sensitive nature of the sensors that mount to it. The windshield will come with the bracket and mirror button attached as an assembly.
