## STAR ONLINE PUBLICATION

**Case Number:** S2108000116

**Symptom/Vehicle Issue:** Max Regeneration Does Not Remain On After Vehicle Is Restarted

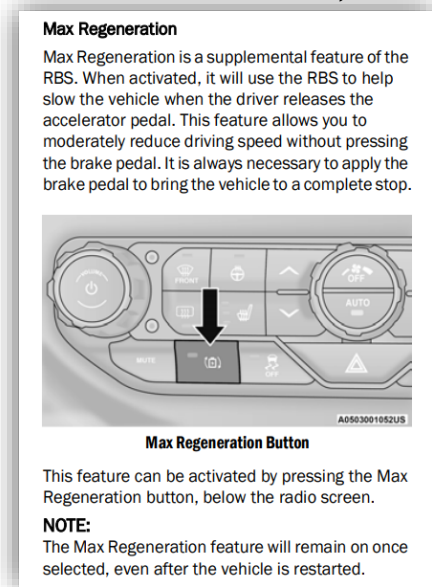
**Discussion:** The Hybrid Supplemental manual states the following: *"The Max Regeneration feature will remain on once selected, even after the vehicle is restarted."*

**Repair:** A Software concern is causing the Max Regeneration feature not to remain on after restarting the vehicle. Part replacement WILL NOT correct this concern. A TSB software package which will update multiple modules has an estimated release date within the 3<sup>rd</sup> quarter of 2021. This SOL will be deleted once a resolution is released to the field.
