STAR ONLINE PUBLICATION

Case Number: S2123000034

Symptom/Vehicle Issue: C15A1-00 Unable To Obtain Desired Ride Height Service Air Suspension Message On Cluster

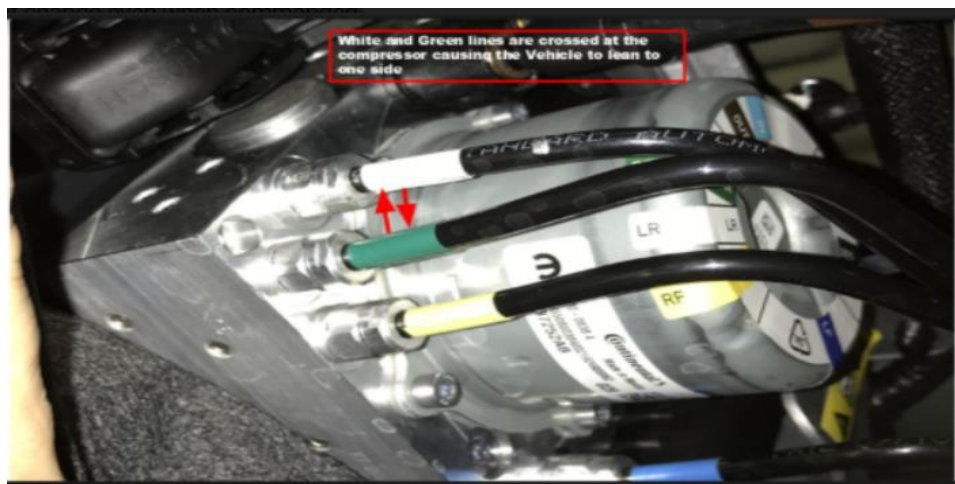
Not ok-

White and green are incorrect

Discussion: The airlines and compressor are color coded to identify which airline goes to what port of the compressor. Verify proper line routing as part of diagnosis.

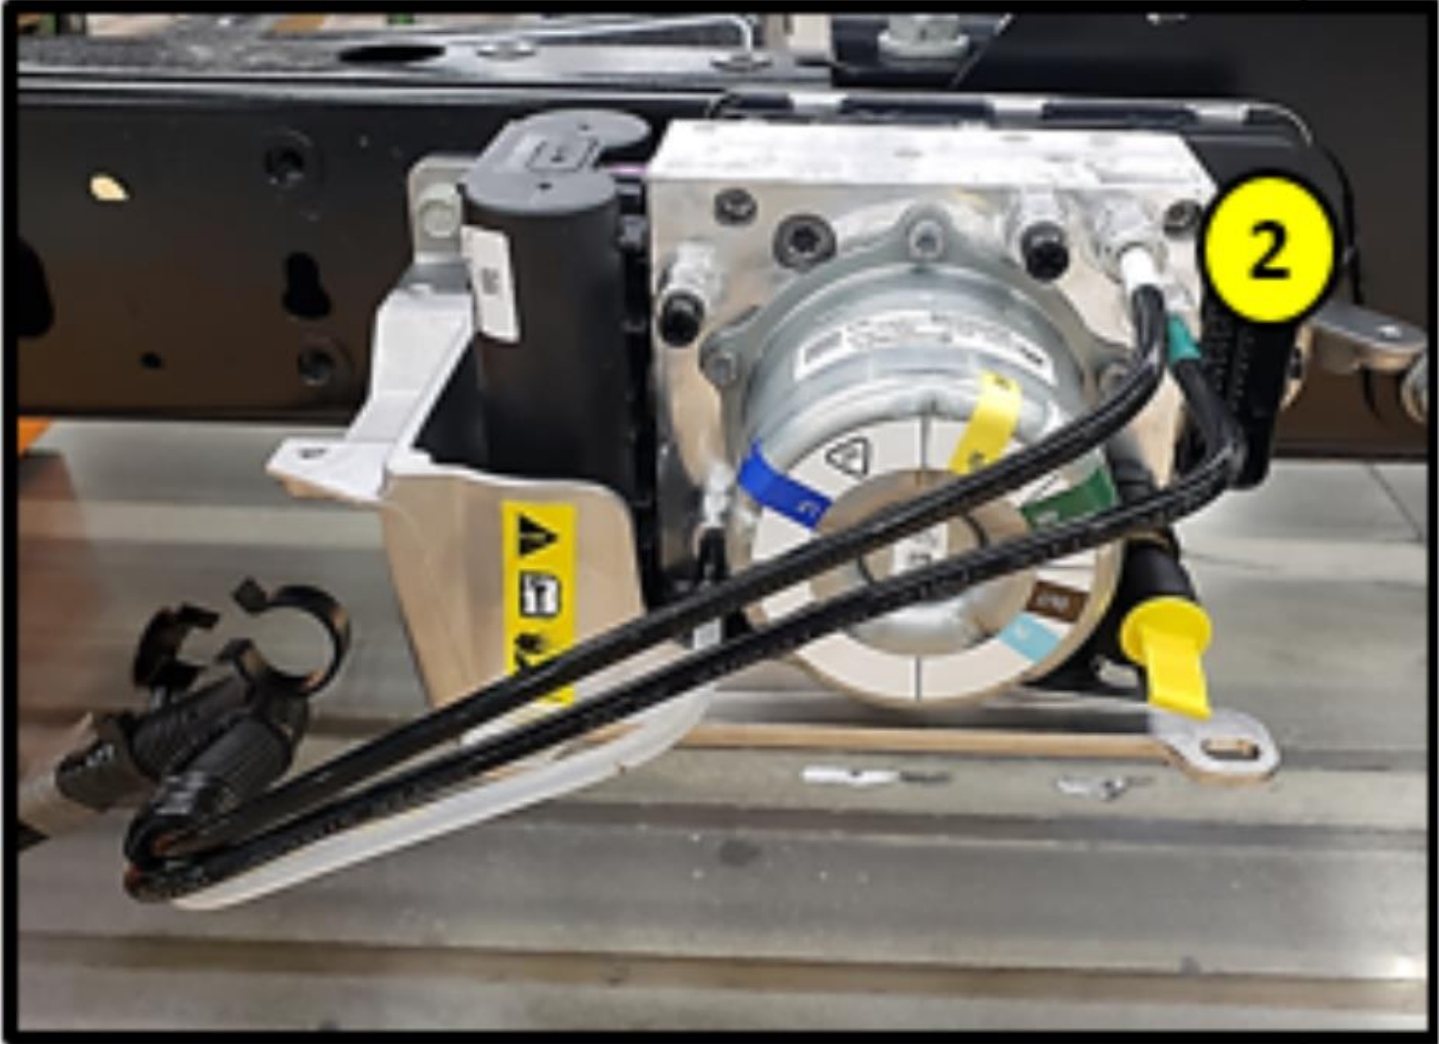
Proper color coding of lines to their ports.
