STAR ONLINE PUBLICATION

Case Number: S2108000121

Symptom/Vehicle Issue: Check Engine Light On And Service Hybrid System Displayed. P0A0A-00 High Voltage System Interlock Circuit "A" Is Active

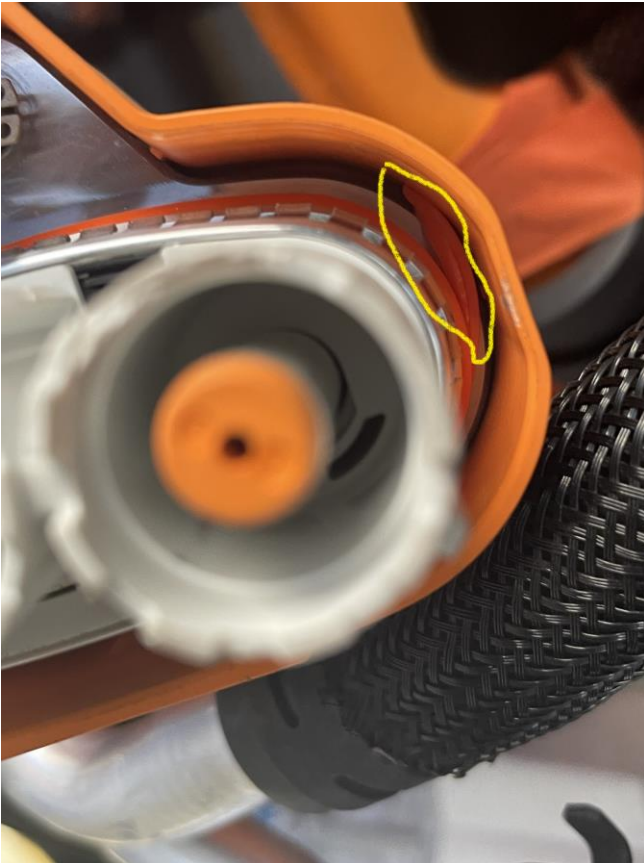
Damaged HV Connector Seal

Inspect the HVIL connector seals for damage or tears and the terminals for spread contacts. If any of the High Voltage connectors seals are damaged, the wiring harness will need to be replaced. If HVIL terminals appear to be spread or damaged, HV component replacement will be necessary. Contact STAR for assistance.

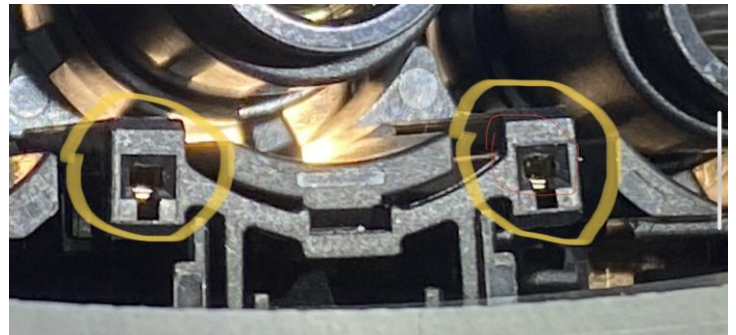
Spread HVIL Terminals
