STAR ONLINE PUBLICATION

Case Number: S2123000039

Symptom/Vehicle Issue: Click Pop Snap Noise From Door Area On Rough Roads Or Body Twist

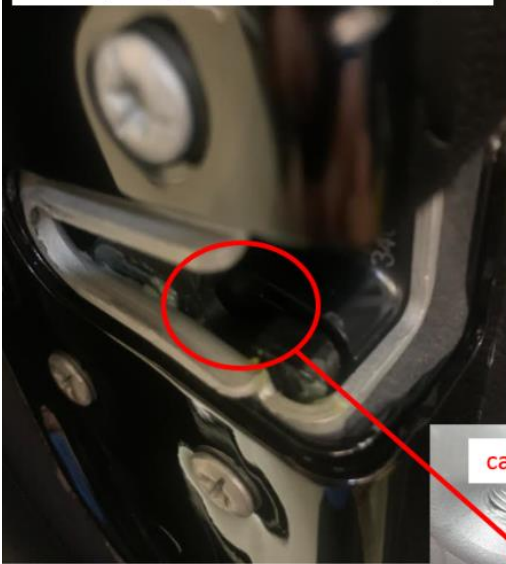
Latch opening view with side door open

Popping sound from side door latch area during aggressive stop and go maneuvers.

Step 1: open side door

Step 2: apply approx. 0.2 grams of Uniflor 8132 grease on small brush (see images as reference)

Step 3: locate "U" shape profile of catch in latch opening (catch is the component that engages with the striker)

Step 4: place grease into "U" shape opening

Step 5: close door

Repeat steps for each front door

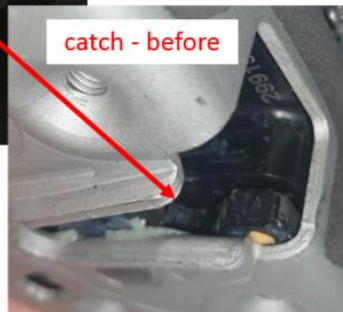
NOK - not enough grease

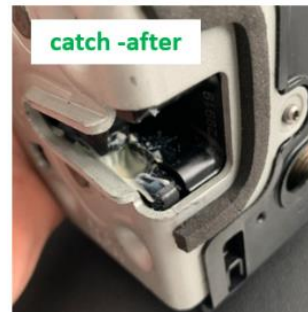
NOK - too much grease
