NUMBER: 08-074-21

GROUP: 08 - Electrical

DATE: May 7, 2021

UGQ, UGV, UJV and UJQ Radio Enhancements

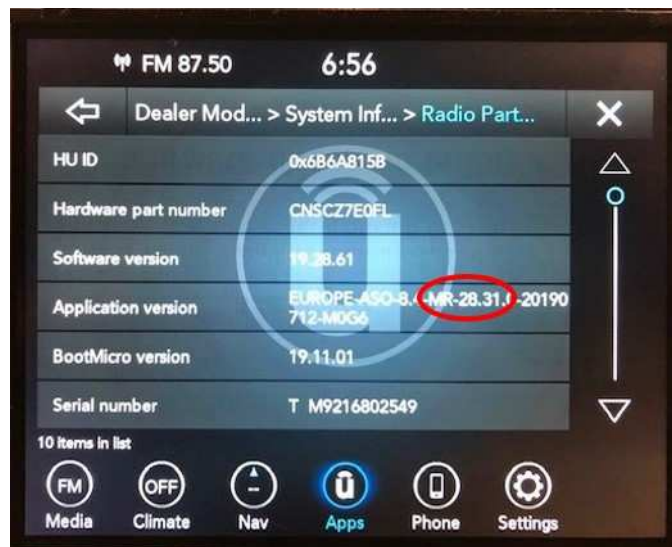
1. Verify the radio software version. Radio must be in Dealer Mode to verify by following these steps:
 - a. Push and hold the front defrost, driver temperature up and temperature down buttons simultaneously until the ‘Dealer Mode’ screen appears (approximately seven seconds). Release buttons.
 - b. Select “Radio Part Information”. The software version will be listed next to “Application Version” (Fig. 1) .

Fig. 1
Radio Software Level Screen

2. What is the radio software level (Application Version) at?
 - 39.2 or higher >>> The radio software is already up to date. Normal diagnostics should be performed.
 - At or above 28.31 and under 39.2 >>> The radio will only need one USB flash drive to update the radio. Create a USB flash drive with 39.2 software. Proceed to (Fig. 2) of the Repair Procedure.

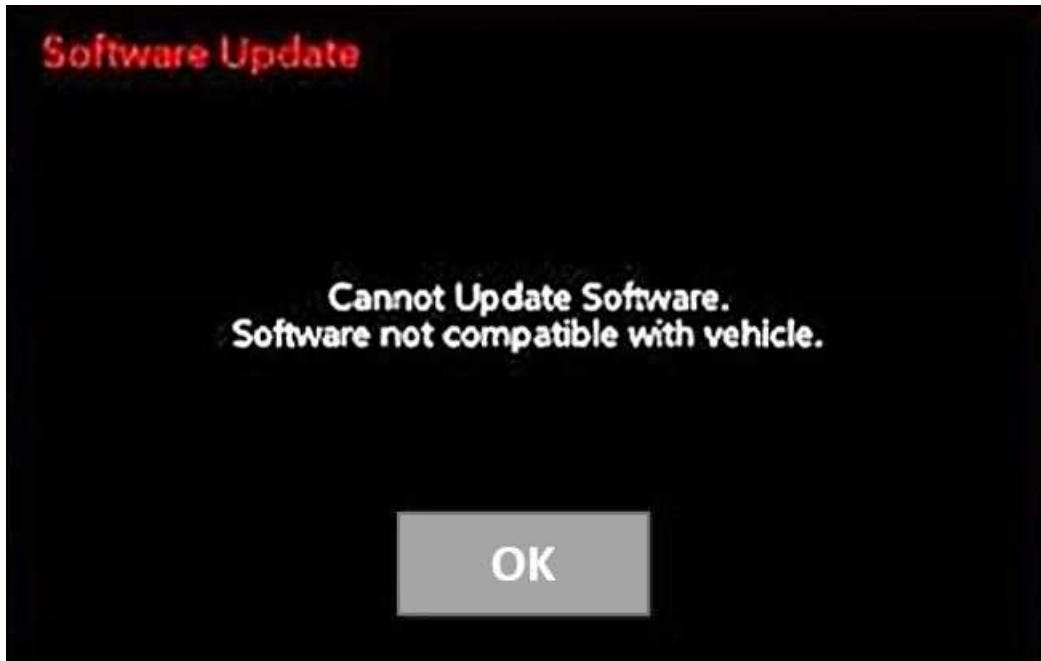
11. If the screen in (Fig. 5) is displayed, the USB flash drive was not set up correctly. Use a top name brand USB flash drive and create a new USB flash drive. Start the update again.

Fig. 5
Software Not Compatible

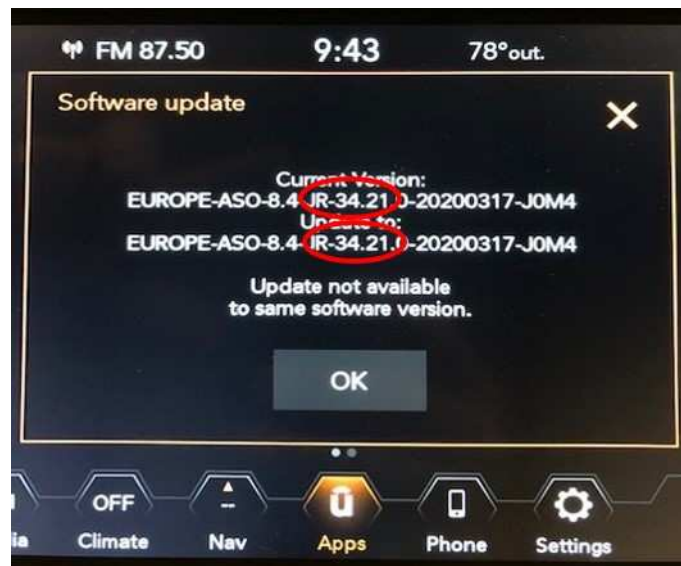
12. If the radio software is up to date, the screen in (Fig. 6) will be displayed. Press "OK" and remove the USB flash drive.

Fig. 6
Screen Displayed When Radio Software Level Is Up To Date

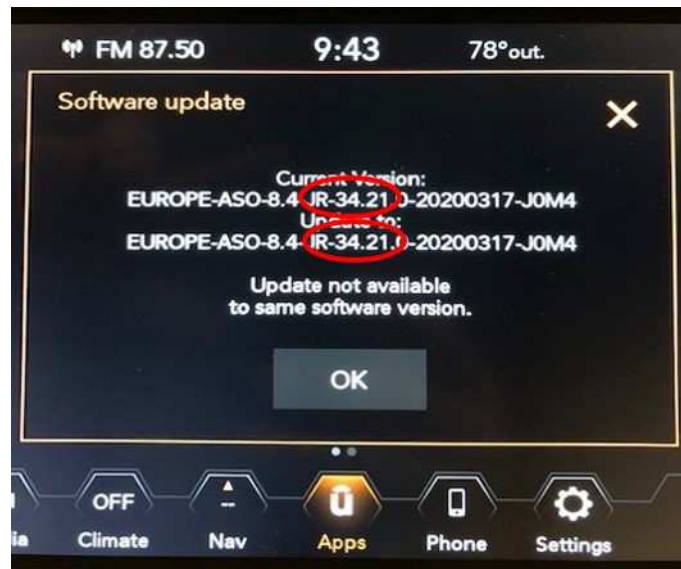
Fig. 9

16. After the update has completed, the radio will shut down. With the USB flash drive still inserted in the USB port, turn the ignition back to the run position. If the radio has been updated correctly, the screen in (Fig. 9) will be displayed. Press “OK” and remove the USB flash drive.

Radio Software Has Been Updated.
