**NUMBER:** 09-006-21

Incorrect Turbocharger Air Outlet Pipe Nuts

This bulletin involves replacing the turbocharger air outlet pipe nuts.

2022 (M1) Jeep Compass (Brazil)

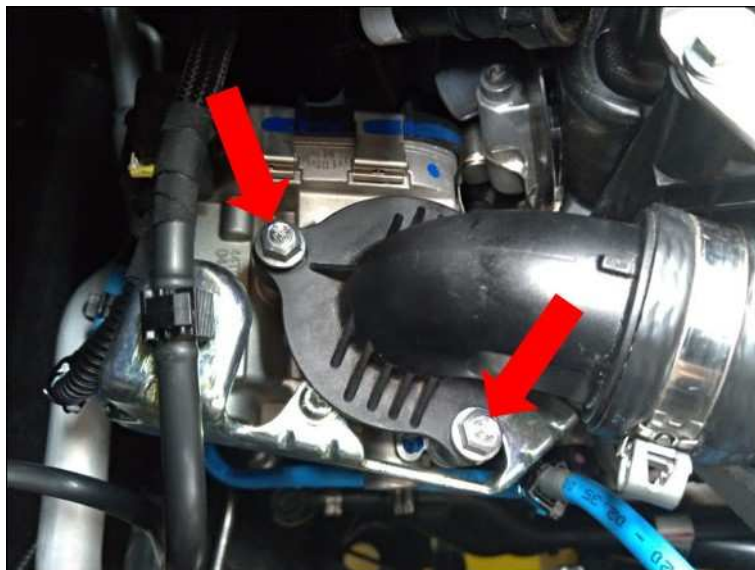
**Fig. 4**  
**Turbocharger Air Outlet Pipe Nuts**

Customers may experience a Malfunction Indicator Lamp (MIL) illumination. Upon further investigation the technician may find that the following Diagnostic Trouble Code (DTC) has been set:

- P0299 - Turbocharger Underboost.

- An air leak noise from the engine compartment.

8. Remove and discard the two nuts (Fig. 4) and disconnect the turbocharger air outlet pipe from the throttle body.

10. Using the new nuts (Fig. 4) , install the turbocharger air outlet pipe. Tighten the new nuts to 10 N·m (88 in. lbs.).
11. Tighten the turbocharger air outlet pipe bolts to 10 N·m (88 in. lbs.).
12. Install the securing the turbocharger air outlet pipe to the cylinder head cover with bolt (Fig. 3) . Tighten bolt to 10 N·m (88 in. lbs.).
13. Fit the pipe into position and tighten retaining bands (Fig. 1) .
14. Connect the quick coupling for the fuel vapor pipe.
15. Install the engine cover. Refer to the detailed service procedures available in DealerCONNECT/Service Library under: Service Info>09 - Engine, 1.3L I4 16V MultiAir Turbo / Cover, Engine / Installation.
16. Connect the negative battery cable.
17. Clear all DTCs that may have been set.
18. Remove the fender cover and close the hood.
