STAR ONLINE PUBLICATION

Case Number: S2108000169

Symptom/Vehicle Issue: Radio Display Abnormality

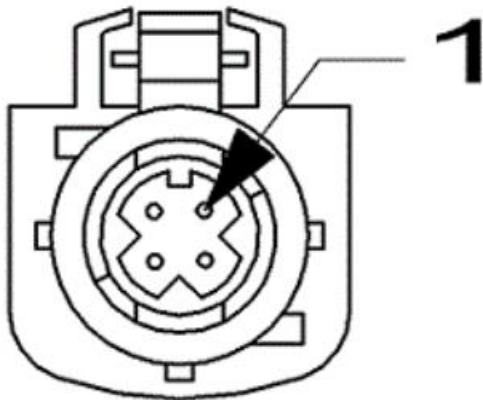
Mating Side:

LVDS cable connectors

1. Please verify cable connections between radio and display, check LVDS cable and connector conditions.
2. Always check the LVDS video cable and display screen before replacing a radio head unit.
