STAR ONLINE PUBLICATION

Case Number: S2123000057

Symptom/Vehicle Issue: Tail lamp Is Tight To The Pickup Box In Upper Inboard Corner

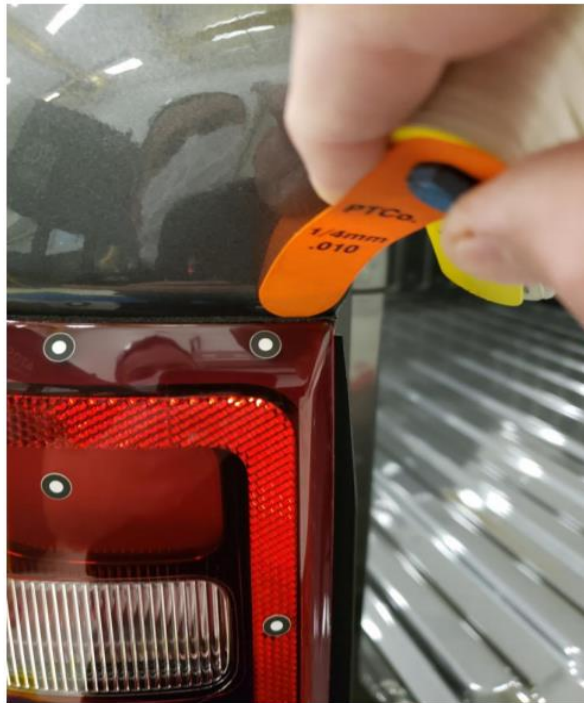
Customer Complaint/Technician Observation: Tail light may be very tight and or cracked on inboard upper corner area (fig 1).

Fig 1. Left tail light upper corner tight to bed.

Discussion: If the gap is tight on the tail lamp (fig 1) the lamp housing fit can be improved. A de-bur tool (fig 3) or a sharp hobby knife can trim the forward edge of the upper locating hole of the tail lamp. Using PPE (personal protection equipment) and safety precautions, carefully trim the forward edge of the hole as shown 1.5mm. Refer to Service Library for details on removal of tail lamp. 08 - Electrical / 8L - Lamps and Lighting / Lamps/Lighting - Exterior / LAMP, Tail Stop Turn / Removal and Installation

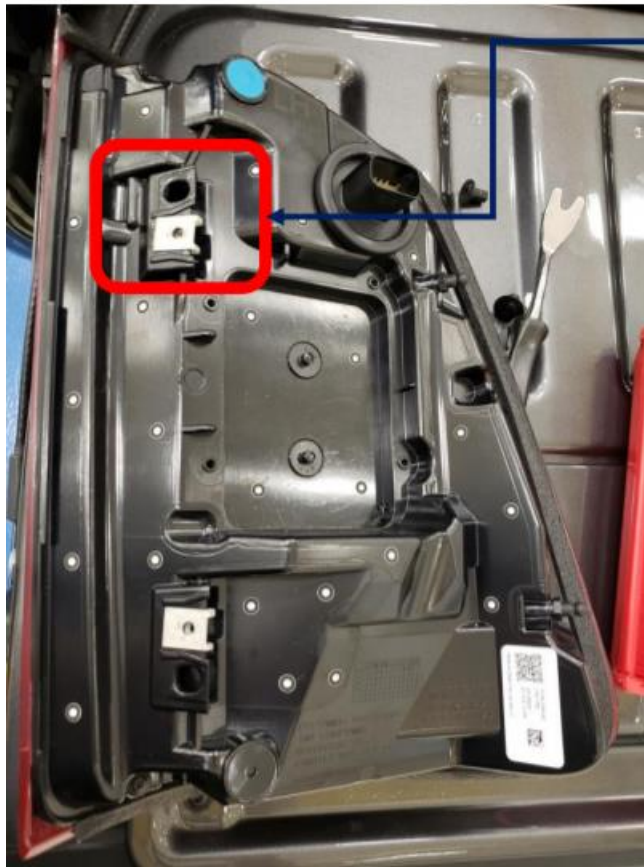
Fig 2
Tail Lamp removed and location of upper locator hole
