STAR ONLINE PUBLICATION

Case Number: S2108000178

Symptom/Vehicle Issue: The Airbag Light Is Illuminated. B2765-11 Right C-Pillar Impact Acceleration Sensor-Circuit Short To Ground

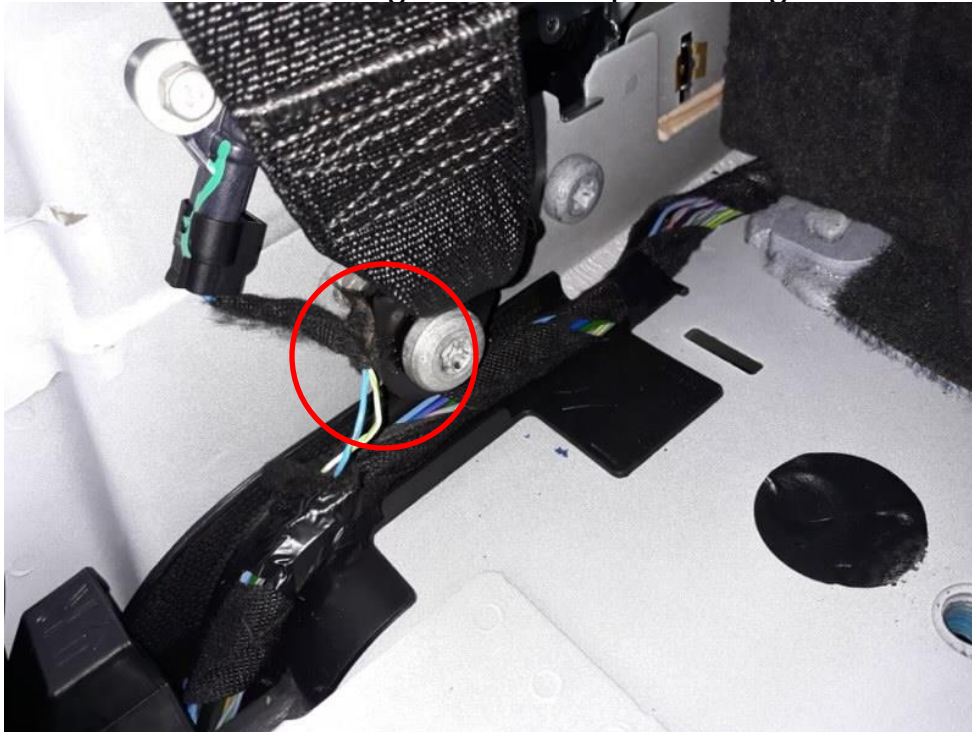
Diagnosis: The right C-Pillar impact sensor wiring may be pinched and shorted to ground at the lower seat belt mounting bracket. Inspect wiring at location shown below.

Repair: Remove the seat belt bracket bolt and relocate the trapped wiring harness. Repair any damaged circuits using standard procedures.
