STAR ONLINE PUBLICATION

Case Number: S2008000190 – REV. C

Symptom/Vehicle Issue: User Is Unable To Create A New Profile In The R1H Radio Uconnect 5

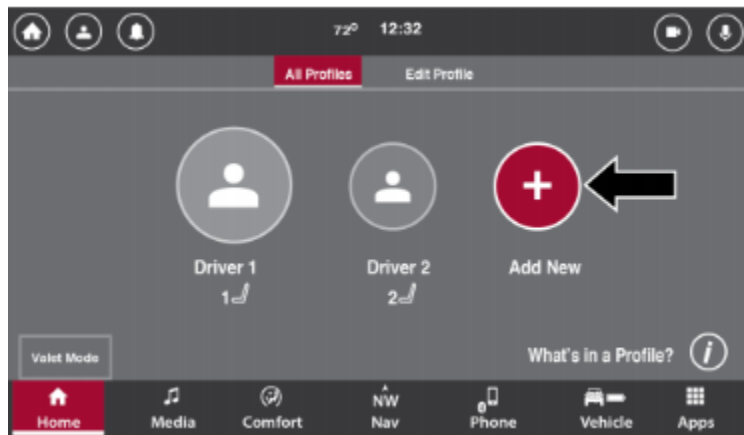
Discussion: User is unable to create a new profile in the R1H Radio. Soft keys are not visible on the radio to add a new profile. This feature is **Not** available, only one profile is available.

Fig 1 Add New Profile.

Do Not Replace The Radio (ETM), TBM, or Display for this concern. The feature will be activated by a software update tentatively in 3rd quarter 2021.
