**NUMBER:** 08-110-21

Radio Enhancements

This bulletin involves inspecting the software level and updating the software if needed. The software will be updated to R17.83.

2021 (WL) Jeep Grand Cherokee

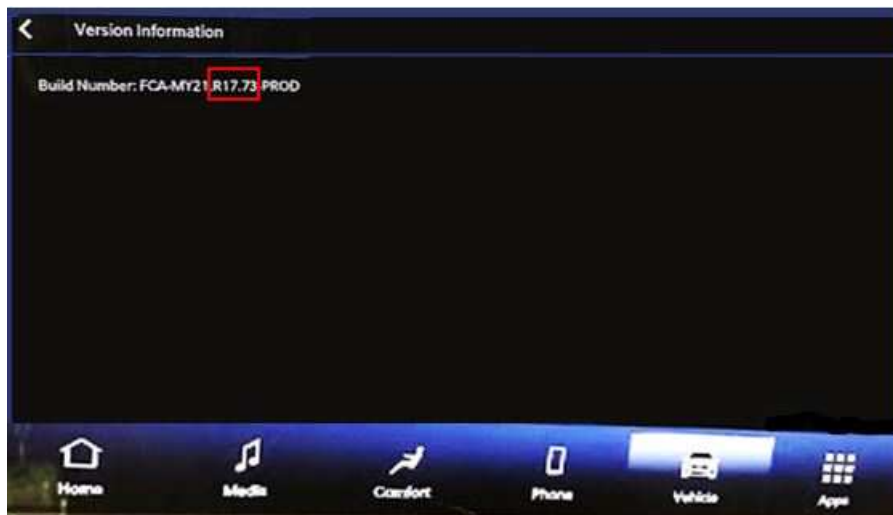
Fig. 1  
Radio Software Level Screen

1. Verify the radio software version, by following these steps:
  - a. On the radio display screen go into "Vehicle Settings".
  - b. Select "System Information". The software level will be listed next to "Radio Version ". (Fig. 1) .

2. What is the radio software level at?
  - R17.83 or higher >>> This bulletin has been completed. Use inspection LOP (18-60-02-EL) to close the active RRT.
  - Under R17.83 >>> The radio will need to be updated. Proceed to [Step 1](#) of the Repair Procedure.

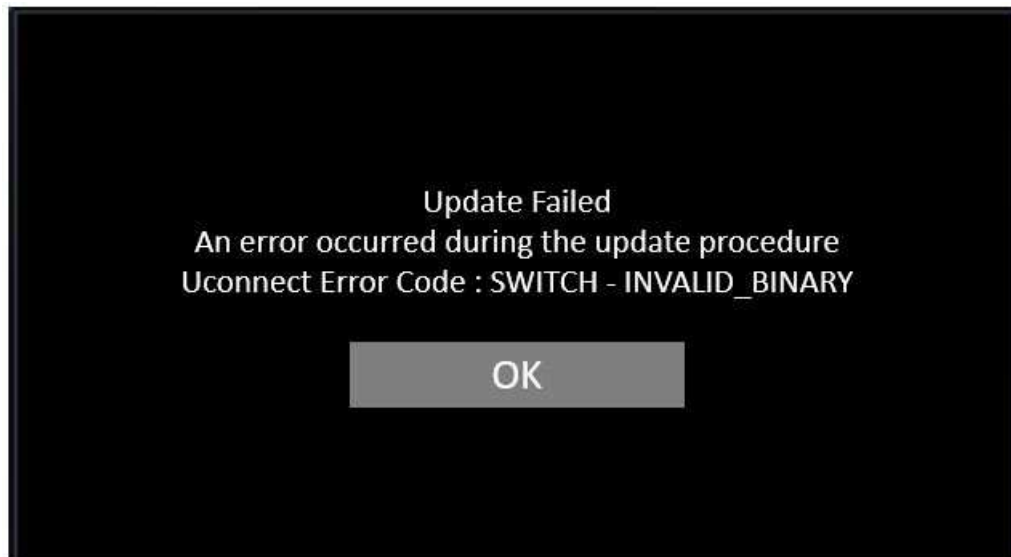
**Fig. 7**  
**Error Message**

- 14. **Do Not** turn off the ignition at this point. The update is still in process, wait until the radio restarts and the home screen is displayed. This should take around five minutes
- 15. Sometimes the radio will display an error pop up “ Invalid\_Binary\_Switch “ after successful radio update. Please ignore this error message and press “OK” to continue (Fig. 7) .
