NUMBER: 08-119-21

DATE: July 20, 2021

UAX, UCX, UAV and UCV Radio Over the Air Software Version Updates

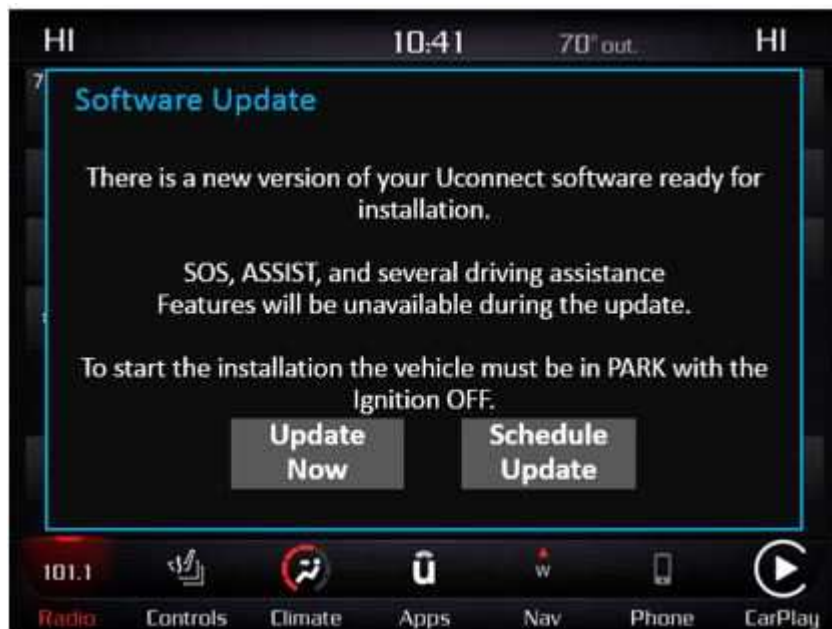
Fig. 1

Customers will see a notification on their radio screen when new software is available for their radio (Fig. 1) . The owner will have the option to update the radio or schedule the update for later. **There is not an option to decline the update indefinitely, the update must be performed.**

Software Acceptance Screen

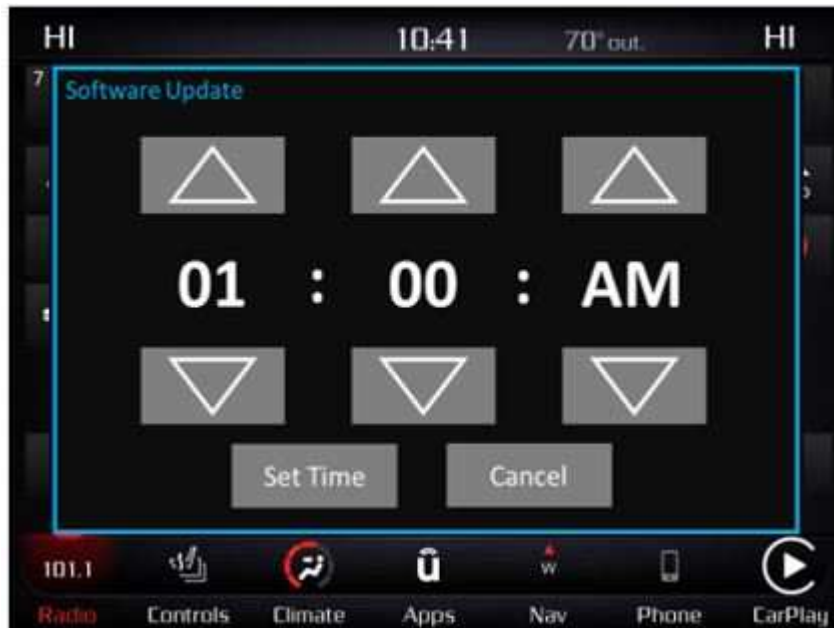
Fig. 2
Schedule Update Screen

NOTE: If selecting “Schedule Update” the screen below will be displayed. The customer can select the exact time they want the update to begin (Fig. 2) .

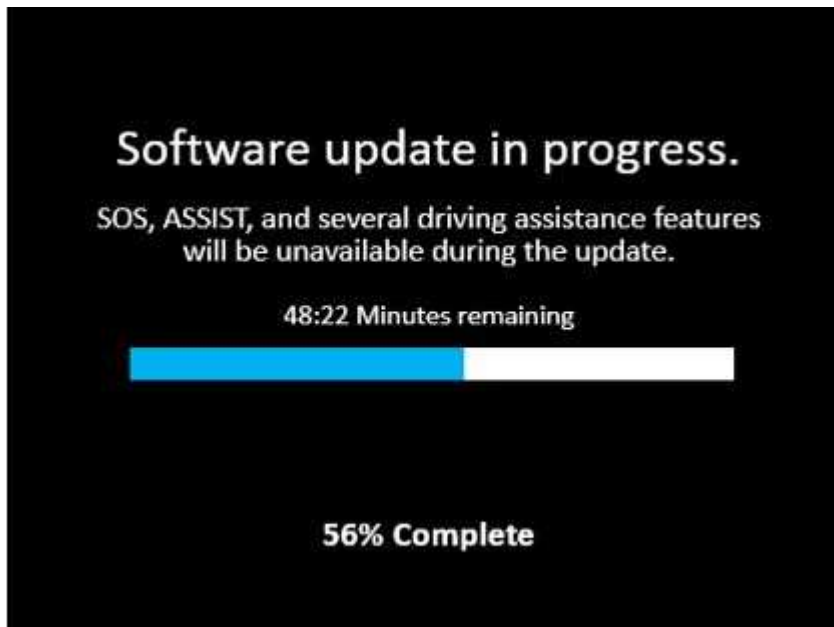
Fig. 3
Update In Progress Screen

1. The vehicle transmission needs to be in the park position, or have the vehicle in neutral with parking brake engaged if equipped with a manual transmission. The ignition needs to be off.
2. Whether the customer selects “Update Now” or “Schedule Update” (Fig. 2) and sets a time, they can shut off the vehicle and leave. The update will be completed automatically (Fig. 3) .

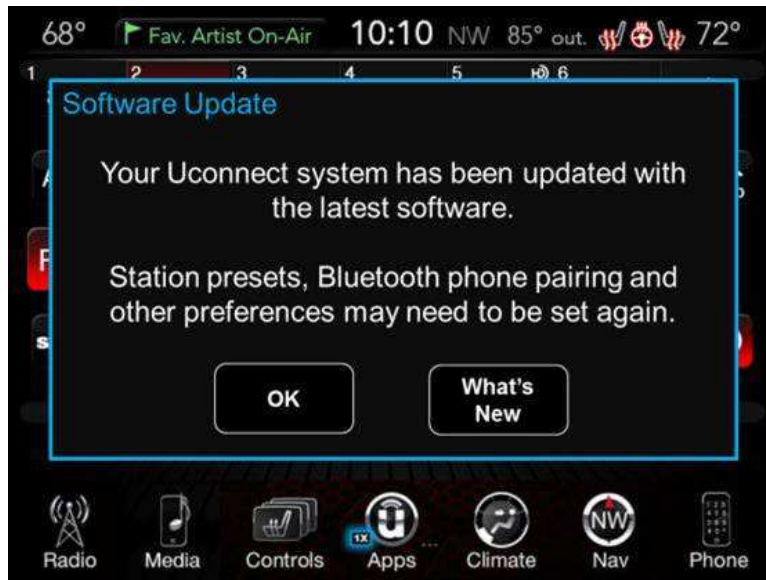
Fig. 4
Update Confirmation Screen

3. Upon completion of update, the radio will display a confirmation message (Fig. 4) .
