Technical Service Bulletin

GROUP Fuel System	NUMBER 21-FL-003G
DATE July, 2021	MODEL(S) G80 (DH)

SUBJECT: DTC U0109/U010900 FUEL PUMP CONTROL MODULE

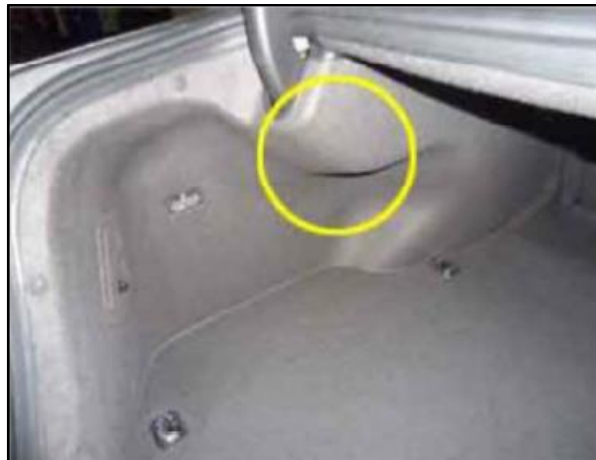
2. Remove the trunk rear transverse trim.
3. Fold the LH luggage side trim to access the FPCM.
