DTC P1CE931 - No Signal From the Charging Fan

YEAR(S)	MODEL(S)	ADDITIONAL INFORMATION
2021	RAV4 Prime

Some 2021 model year RAV4 Prime vehicles may store Diagnostic Trouble Code (DTC) P1CE931 (Charger Cooler Fan Revolution Sensor No Signal). Some vehicles may also exhibit a longer charging period or reduced charging efficiency. The charger assembly plug-in logic has been modified to reduce the possibility of these conditions. Follow the Repair Procedure in this bulletin to address these conditions.

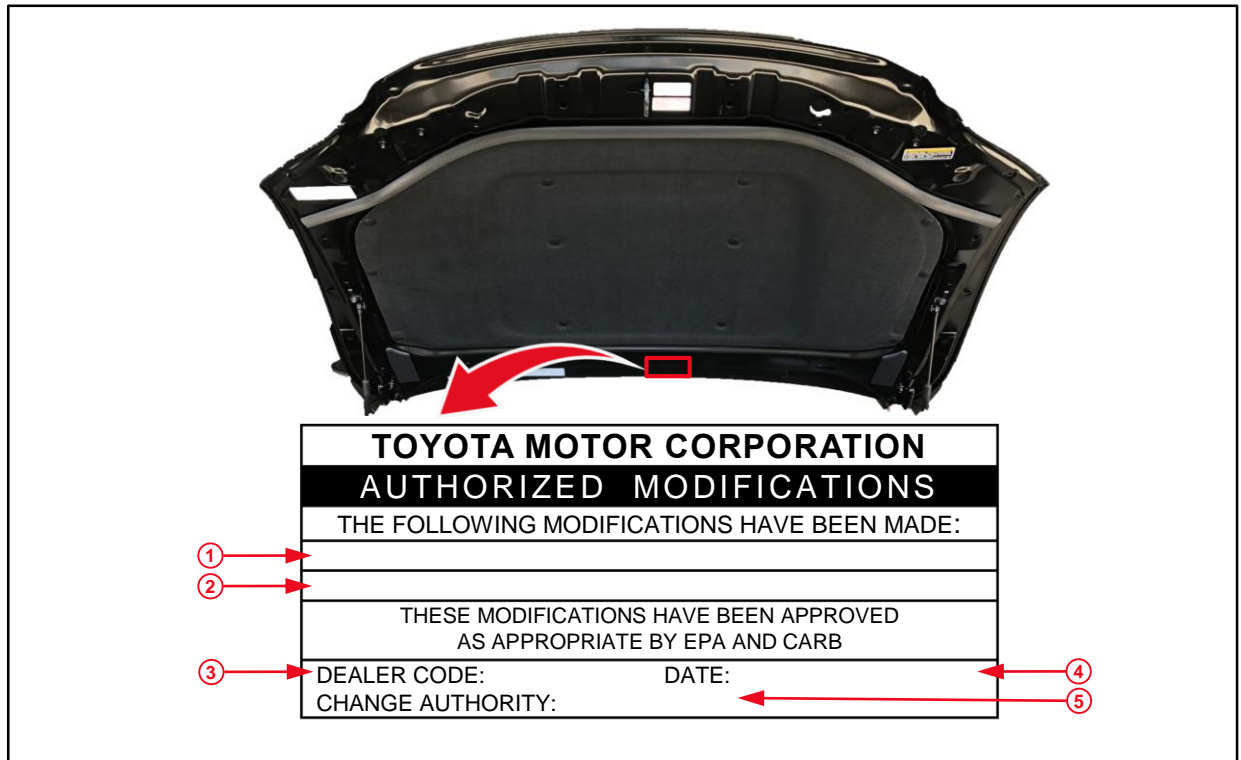
Figure 1. Location of Authorized Modifications Label on 2021 RAV4 Prime

- Use Techstream to confirm if the charger assembly plug-in calibration has been updated and check for the Authorized Modifications Label affixed to the vehicle in the location shown below.

- Prepare and install the Authorized Modifications Label.
 - Using a permanent marker, enter the following information on the label:
 - ECM (PCM) part number [*Refer to the **Parts Information** section for the **NEW PART NUMBER**.*]
 - Calibration ID(s) [*Refer to the **Calibration Information** section for the **NEW CALIBRATION ID**.*]
 - Dealer Code.
 - Repair Date.
 - Change Authority [***This bulletin number***].
 - Install the Authorized Modifications Label onto the vehicle at the location shown in Figure 1. The Authorized Modifications Label is available through the MDC, P/N 00451-00001-LBL.
- Test-drive the vehicle to confirm proper operation and ensure the condition is no longer present.
