**January 14, 2022**

**Product Improvement: Multi-Model 3G OTA TCU Software Update****AFFECTED VEHICLES**

On February 22, 2022 the current 3G network that the vehicle connects to for services, will no longer be in-service. The Telematics Control Unit (TCU) Over the Air Update (OTA) is required to connect to the VoLTE network to continue communications.

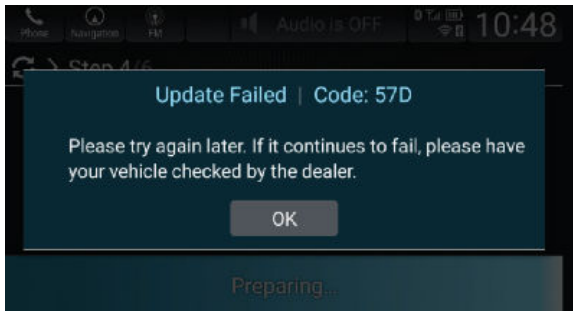
- If you see CODE: 57D or CODE: 5AC, the **Update Failed** due to **Poor cellular signal**.

- Move the vehicle to an open-air area to get **Optimal Cellular Signal** strength.

- Go back to step 1 to start the process once again
