15-22-01TT - Camshaft Timing Faults P0011, P0014, P0016, P0341, P0017 after Engine or Cylinder Head Replacement

Release date: 1/21/2022

Model(s)	Year	Eng. Code	Trans. Code	VIN Range From	VIN Range To
Jetta	2013-2022	1.4L (CNLA, CZTA,DGXA, DJXA)	All	All	All

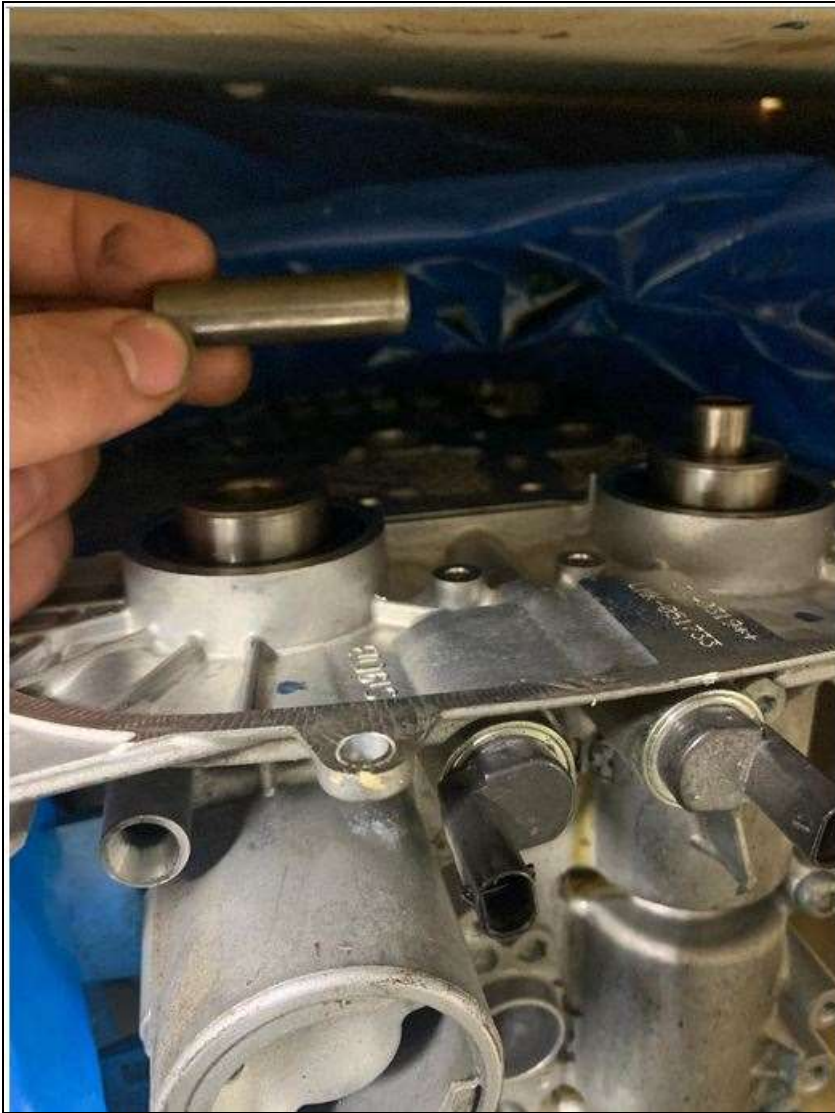
Figure 1

The technician may find camshaft timing faults after a cylinder head or engine replacement. The cam adjuster spacer tubes may not have been transferred from the original engine or cylinder head.

If camshaft timing faults are encountered after engine or cylinder head replacement, check for cam adjuster spacer tubes on the camshafts of the original engine. Usually there are not provided on the replacement engine (Figure 1).
