**TECHNICAL SERVICE BULLETIN****22-2004****Illuminated ABS Indicator, Engine Will Not Turn Off And/Or Various Electrical Symptoms - BJB Cover Not Fully Seated**11 January  
2022

Ford
2020-2022 F-Super Duty

This article supersedes TSB 21-2176 to update the vehicle model years affected.

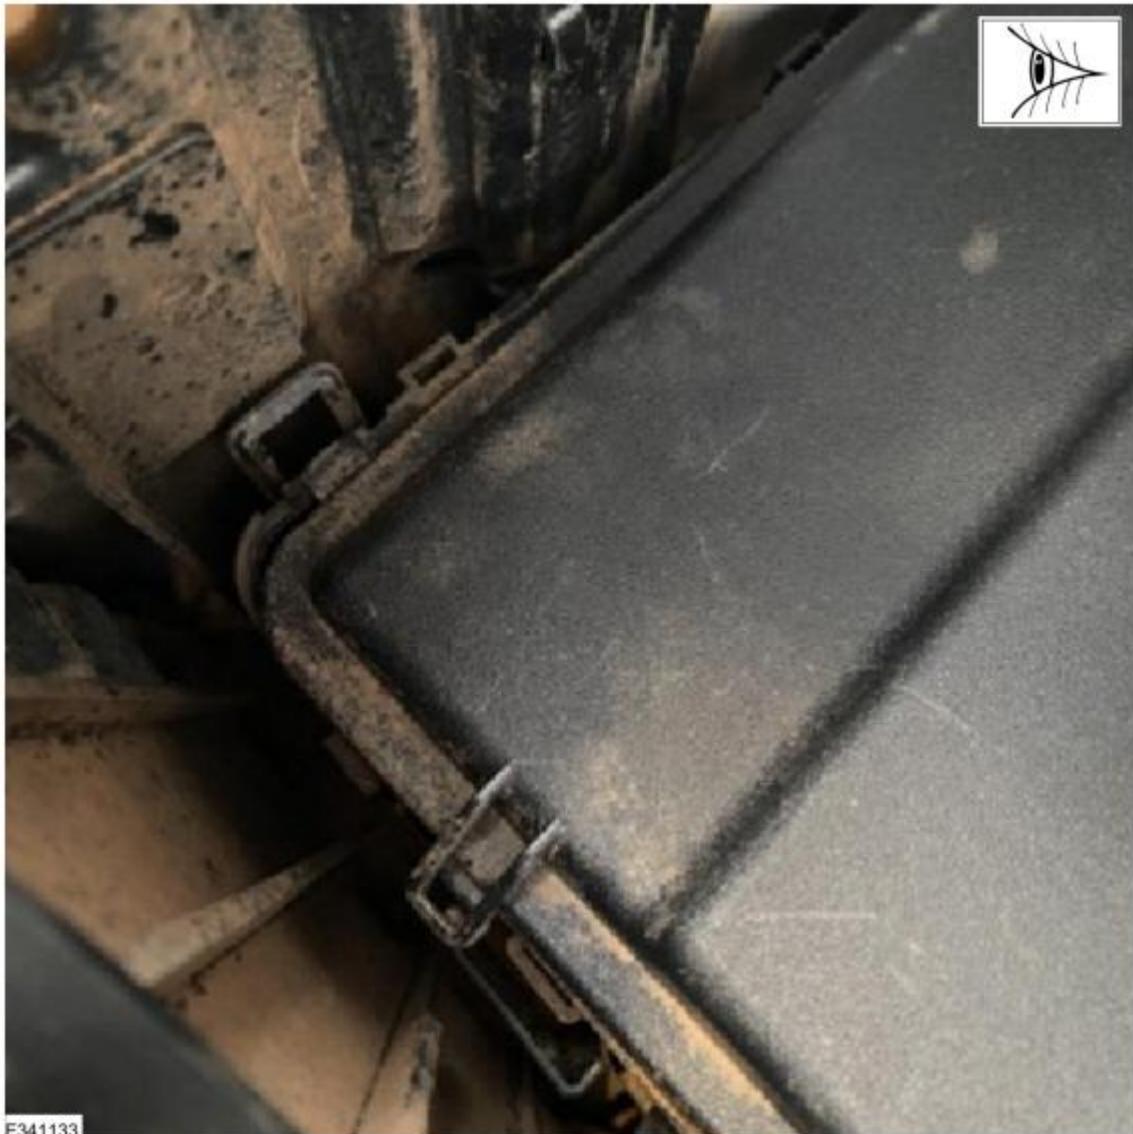
1. Visually inspect the BJB for signs of water/moisture intrusion. Are there signs of water/moisture intrusion into the BJB and/or broken cover tabs/locking fingers?
  - (1). Yes - proceed to Step 2.

Figure 1 - Example of moisture intrusion with BJB cover on

**2. Replace the BJB assembly.**

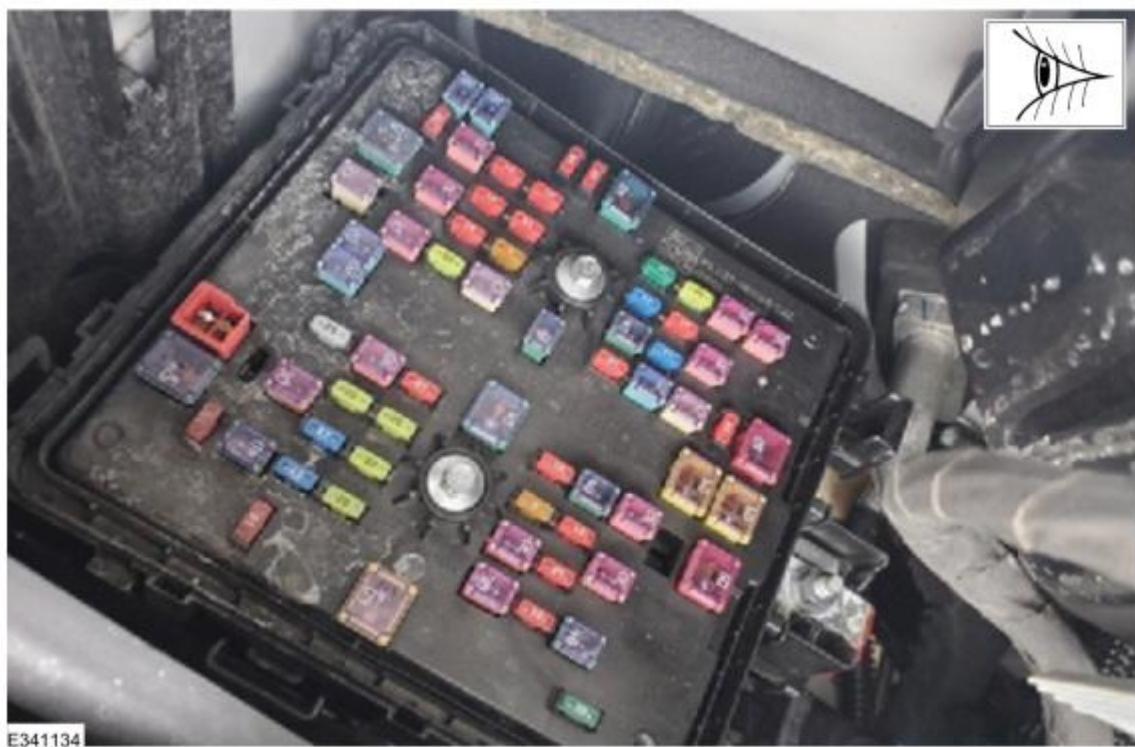
Figure 2 - Example of moisture intrusion with BJB cover off

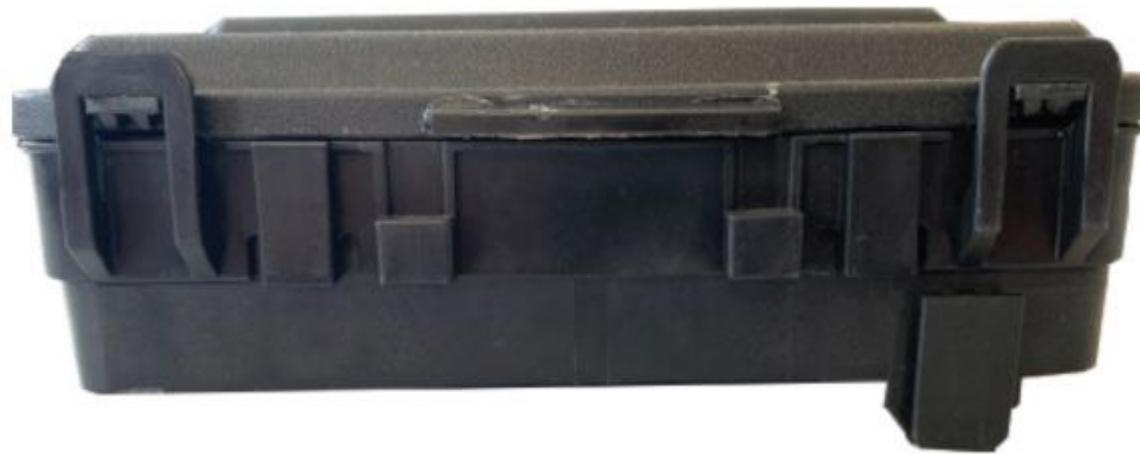
E341135

Figure 3 - Correct cover installation

- (9). Install the new BJB cover making sure the cover tabs/locking fingers are installed correctly.
- (10). Install the battery tray and battery back into the vehicle. Refer to WSM, Section 414-01.

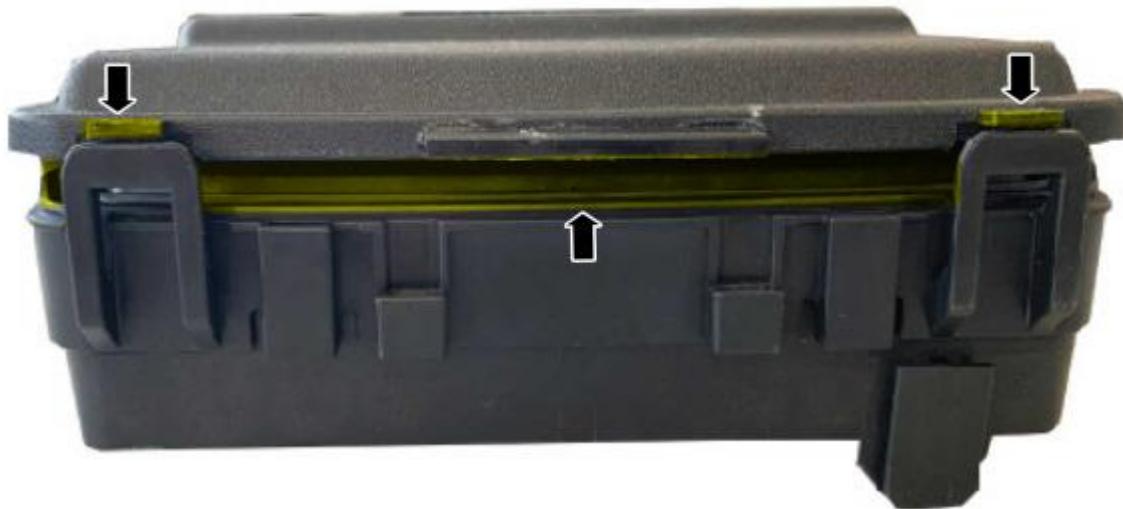
E341136

Figure 4 - Incorrect cover installation

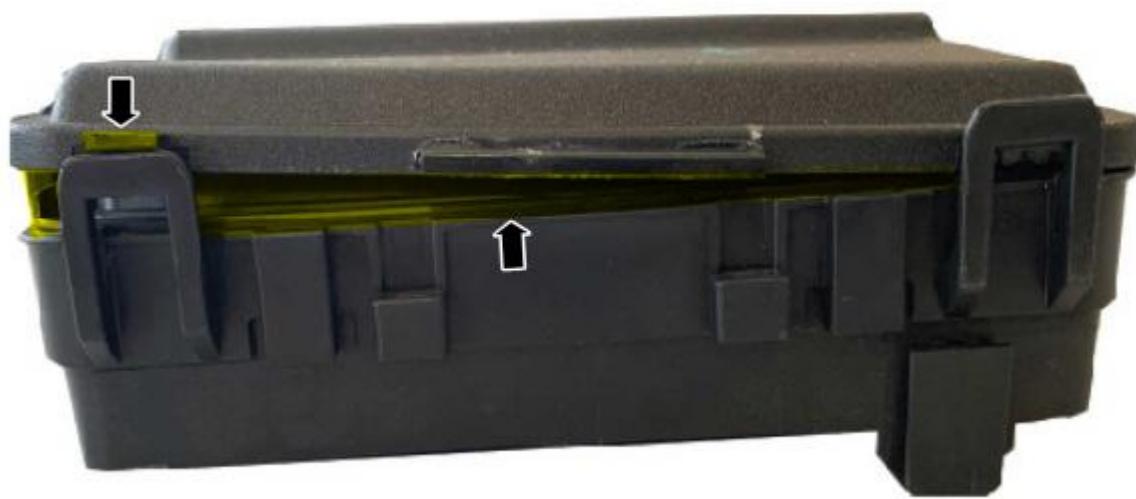
E341137

Figure 5 - Incorrect cover installation

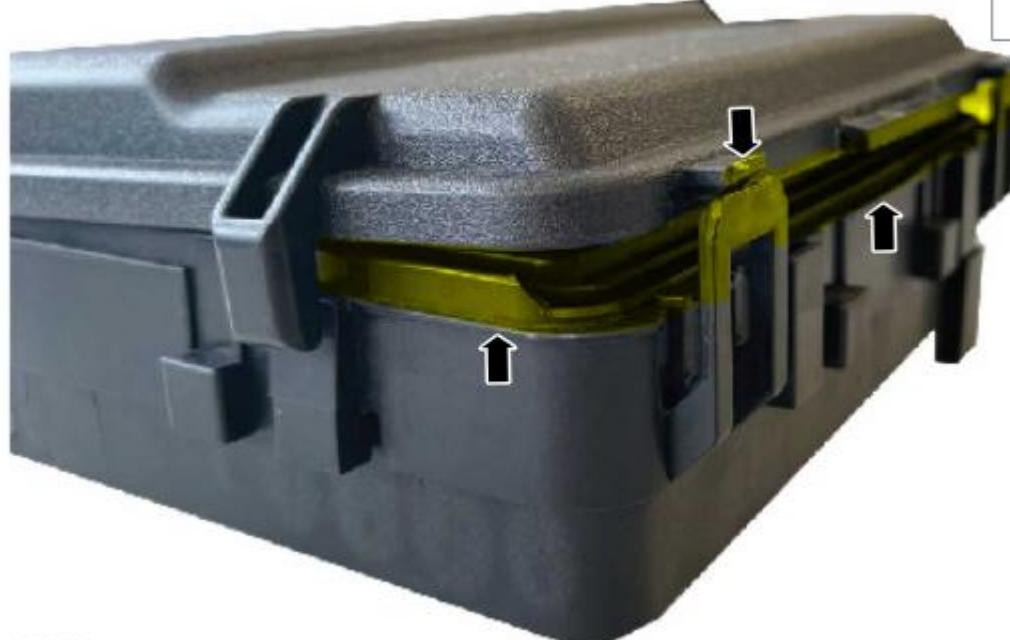
E341138

Figure 6 - Incorrect cover installation
