## TECHNICAL SERVICE BULLETIN

### 1.0L EcoBoost - Cruise Control Inoperative, Illuminated Powertrain Malfunction (Wrench) Indicator And Brake Warning Indicator With DTC P0504

**22-2011**21 January  
2022**Model:**

<b>Ford</b> 2021 EcoSport	Engine: 1.0L EcoBoost
------------------------------	-----------------------

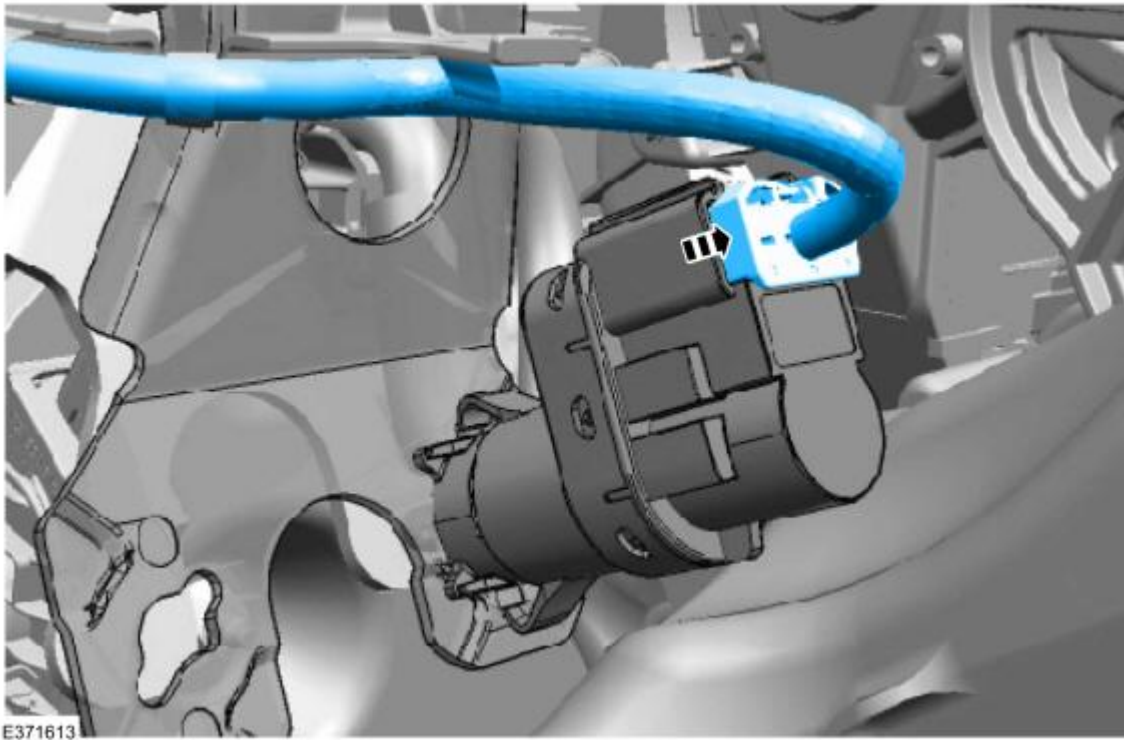
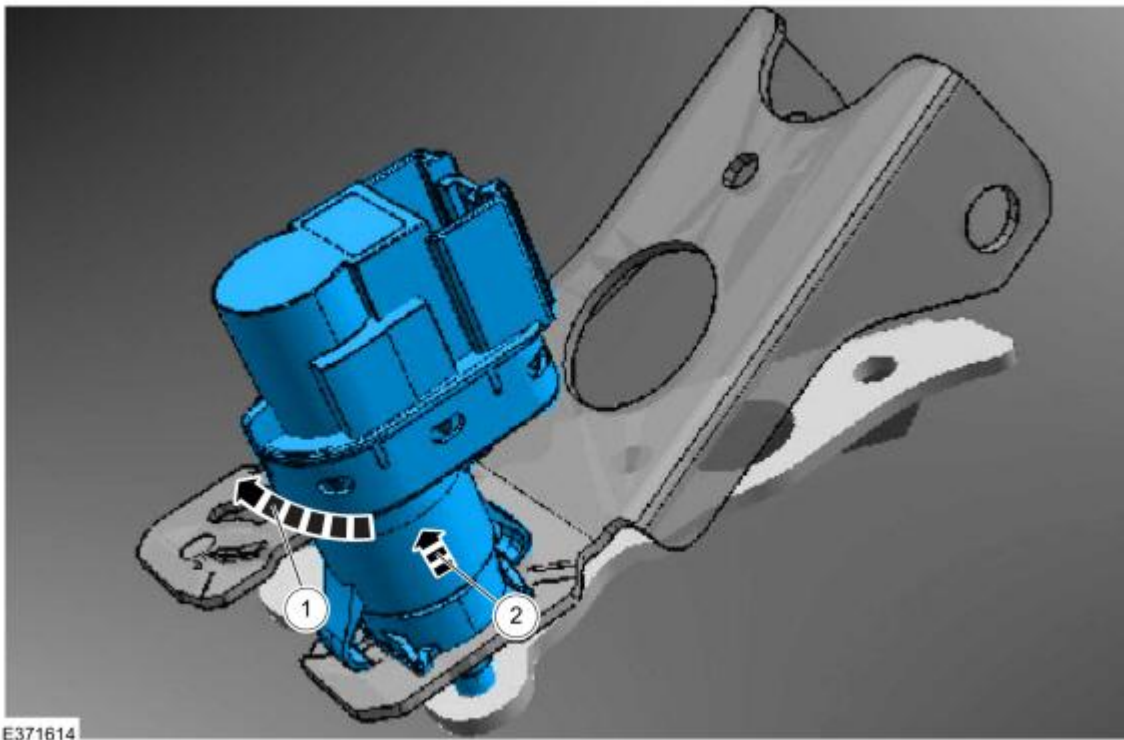
- (2). No - proceed to Step 2.
- 2. Is DTC P0504 present in the PCM after performing the PCM software update and/or has the stoplamp switch been recently replaced?
  - (1). Yes - proceed to Step 3.
  - (2). No - repair is complete.
- 3. Disconnect the electrical connector and remove the stoplamp switch (Figure 1-2). Refer to the Workshop Manual (WSM), Section 417-01 > Exterior Lighting > Removal and Installation. Is it difficult to rotate the stoplamp switch?
