January 21, 2022

SUBJECT: **Customer Satisfaction Program 21B11**
Certain 2014-2016 Model Year Explorer Vehicles
2nd Row Inflatable Seat Belt

CERTAIN 2014-2016 MODEL YEAR EXPLORER VEHICLES — SECOND ROW INFLATABLE SEATBELT

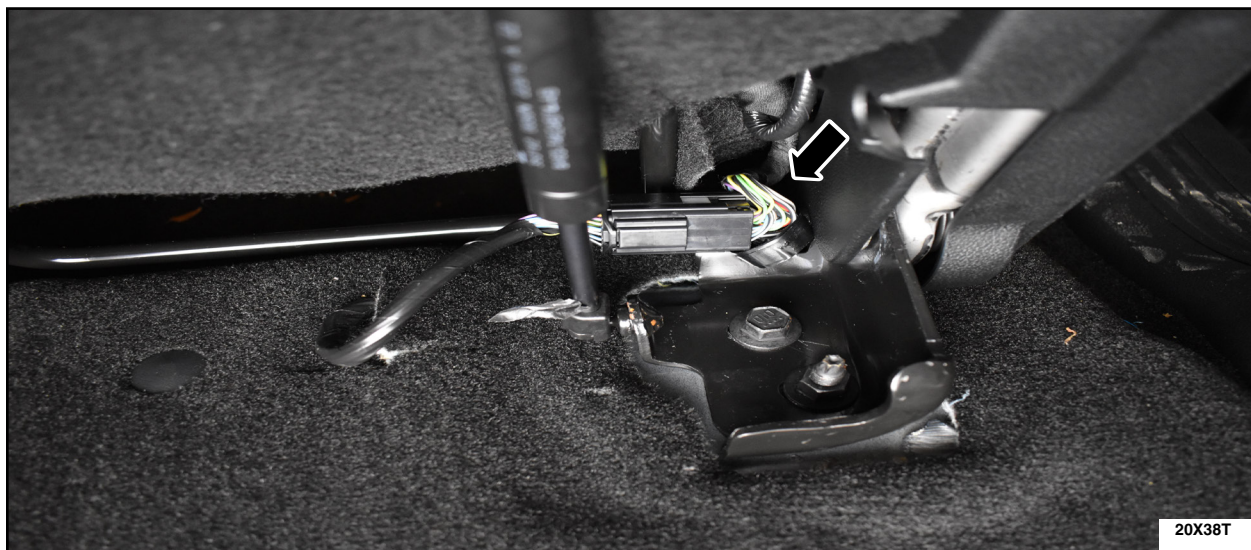
FIGURE 1

NOTE: DTC's may indicate possible internal wire damage in the seat wire harness.

2. Fold the Left Hand (LH) and Right Hand (RH) second row seats forward and inspect the wiring harness for damage. Is the wire harness damaged on either the RH or LH seat? See Figure 1.

If YES - For RH: Proceed to Wire Harness Repair and Rerouting Procedure on Page 8.
- For LH: Proceed to Wire Harness Repair and Rerouting Procedure on Page 8.

If NO - For RH: Proceed to Wire Harness Stress Relief Procedure on Page 2.
- For LH: Proceed to Wire Harness Stress Relief Procedure on Page 2.
