<b>Subject:</b>  SIDE PIPING PART OF FRONT SEAT BACK TRIM IS TORN	<b>Bulletin No.:</b> 09-002/22
	<b>Last Issued :</b> 01/18/2022

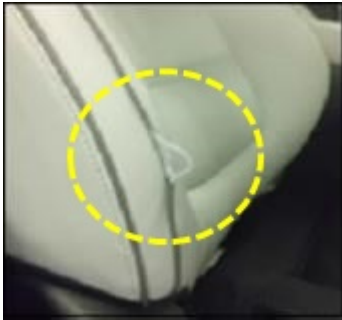
Some customers may complain about the poor appearance of the seat because the front seat back trim side piping is torn.

This is caused by the piping of the front seat back trim rubbing against clothes when passengers get in and out of the vehicle, fraying the seam, and resulting in protrusion of the plastic core wire.

1. Verify the customer concern.
2. Replace the front seat back trim with the modified one according to the instructions on MGSS (FRONT SEAT BACK TRIM REMOVAL/INSTALLATION).

**NOTE:** The service part does not have a plastic core in the side piping of the seat back trim.
