Technical Service Bulletin

Subject: BLIND SPOT MONITORING (BSM) FALSE DETECTION AFTER COLD START	Bulletin No.: 15-001/22
	Last Issued : 01/12/2022

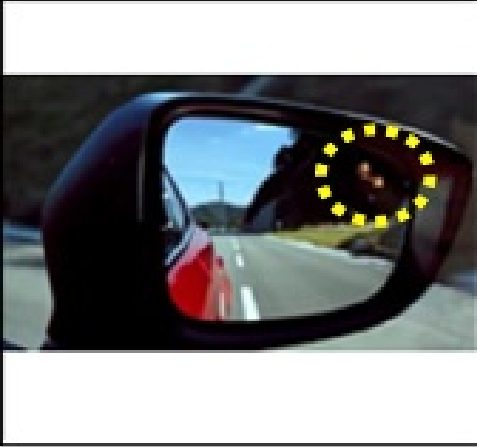
Some vehicles equipped with Blind Spot Monitoring (BSM) may experience a BSM indicator light on the outer door mirror, even if there is no vehicle in the alert (blind spot) area.

NOTE: This concern occurs only after a cold start. As the BSM control module temperature rises, the BSM system returns to normal operation.

Due to BSM control module production variances, a false detection may occur in some units when the BSM temperature in the control module has not yet reached normal operating temperature. To eliminate this concern, the control logic of the BSM control module has been modified.

1. Verify the customer concern.
2. Replace the BSM control module of affected side with a modified one according to MGSS online BLIND SPOT MONITORING (BSM) CONTROL MODULE REMOVAL/INSTALLATION.

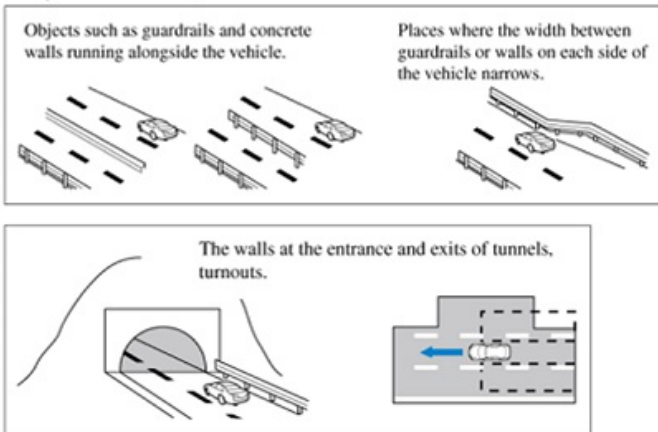
ATTENTION: This Service Information is **NOT** applicable to the following situations described in the owner's manual.

The BSM warning indicator light may turn on and the vehicle detection screen may be displayed in the display in reaction to stationary objects (guardrails, tunnels, sidewalls, and parked vehicles) on the road or the roadside.
