Technical Service Bulletin

| Subject: SCBS WARNING LIGHT WITH DTC U045A:68 AND/OR PARKING SENSOR INDICATOR FLASHING WITH DTC B1B36, B1B38, B1B40 AND/OR B1B42 | Bulletin No.: 15-002/22 |

2017-2021 CX-5 with front parking (ultrasonic) sensor

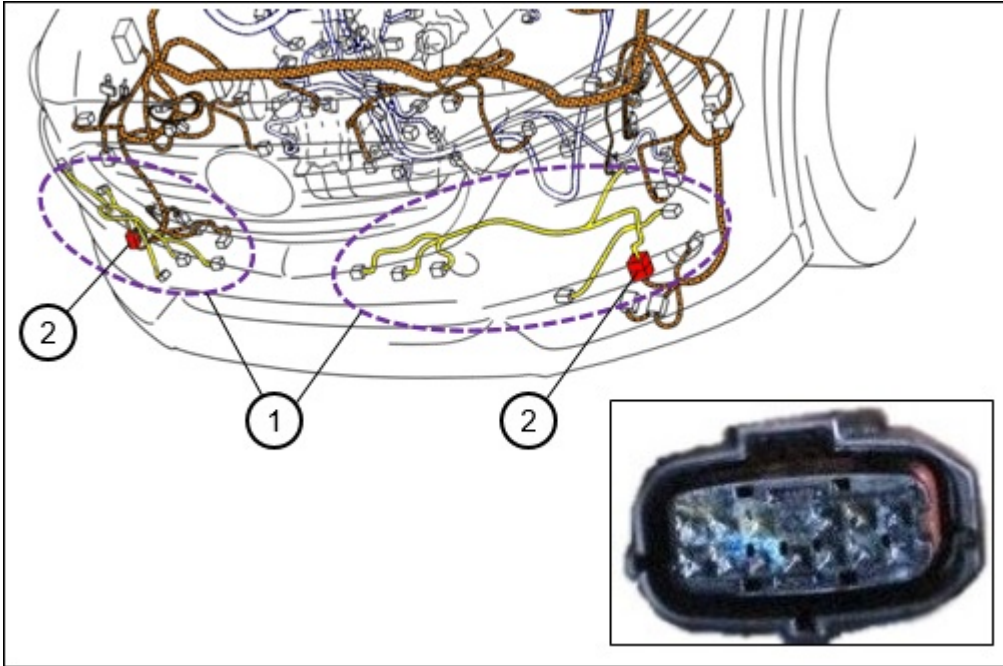
Due to insufficient waterproof performance of the front harness short cords (1), water may enter in and accumulate in the C-11 (LH) or C-12 (RH) connectors (2) causing a short circuit between wires and an improper signal being sent from the parking (ultrasonic) sensor to the parking sensor unit.

Sample picture shows C-11 connector with water entry and terminal corrosion.

To eliminate this concern, the production process of the front harness short cord has been improved to increase waterproof performance.
