Technical Service Bulletin

51 Water sloshing sound is heard while driving

51 22 23 2061754/3 January 7, 2022. Supersedes Technical Service Bulletin Group 51 number 21-21 dated April 20, 2021 for reasons listed below.

Model(s)	Year	VIN Range	Vehicle-Specific Equipment
A5 Sportback, S5 Sportback, and RS5 SPortback	2018-2022	All	Not Applicable

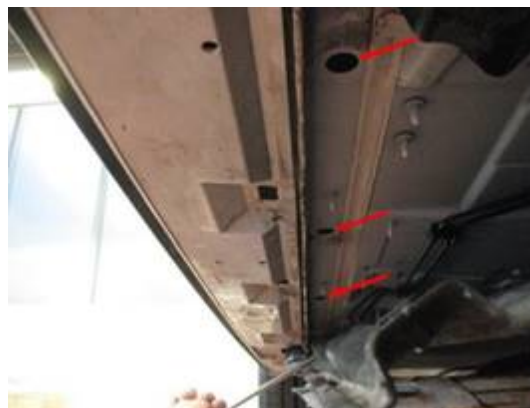
Figure 1. Access to the side member plugs.

1. Detach the underbody trim until the plugs for the side member are accessible. If water has already accumulated in the sill areas water will flow from these plug openings (Figure 1).

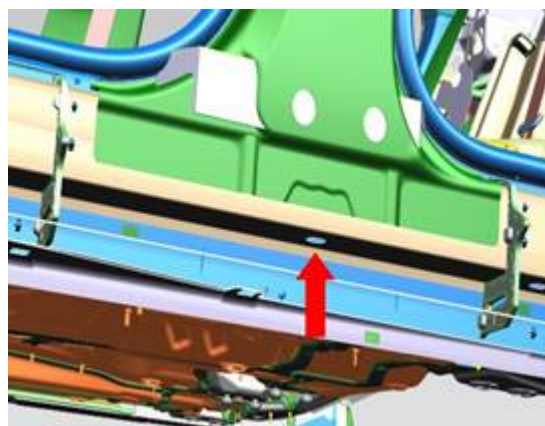
2. Figure 2 shows the opening where water generally enters this space.

Figure 2. Water entrance point.

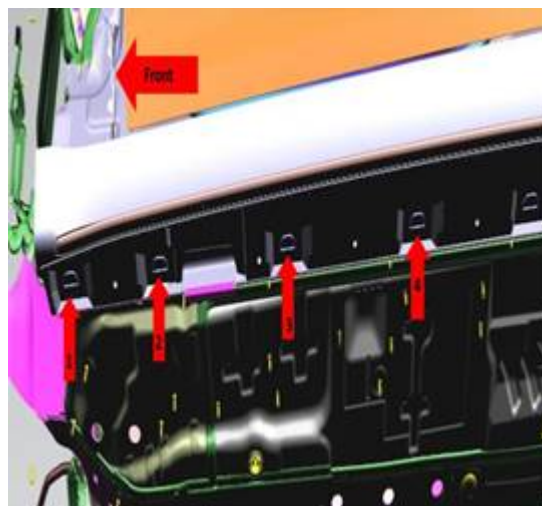
Figure 3. Sill trim fastener openings.

3. Fastener position number 4 shown in Figure 3 is the opening through which a modification to the sound absorber will be made.

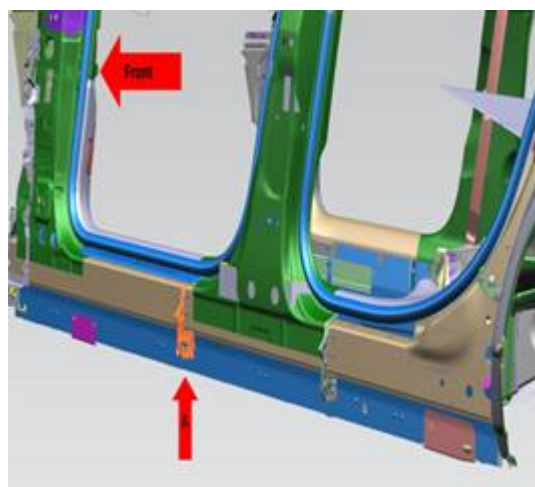
It is possible over time for water to accumulate in the side members and sills but the water is not able to drain as needed. The accumulated water is unable to reach the normal drainage because the sill cavity sound absorber blocks its flow. This accumulated water creates a 'sloshing' noise when the vehicle moves.

4. Figure 4 shows the location of the sound absorber marked 'A'.

Figure 4. Location of the sound absorber.

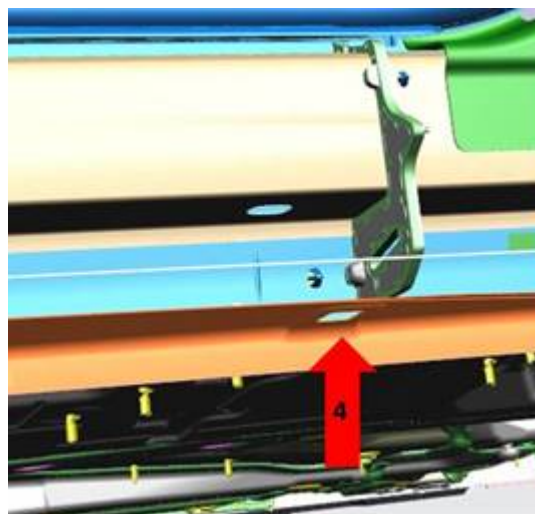
Figure 5. Hole through which the sound absorber will be accessed.

5. Figure 5 shows a closer view of the sound absorber to be modified in the cut-away image.

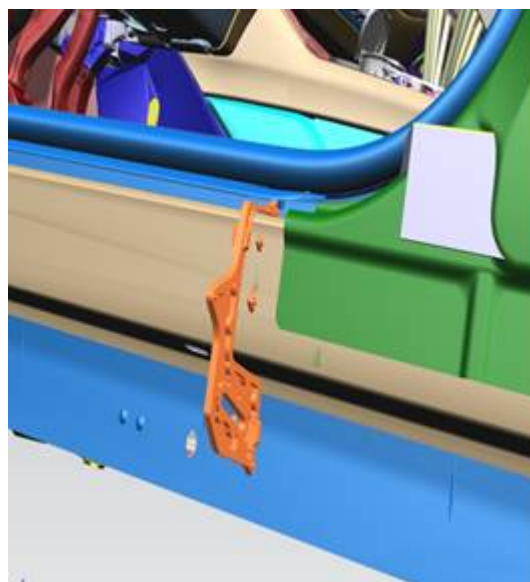
6. Figure 6 shows a cut-away view of the sound absorber from the rear.

Figure 6. Side member cavity sound absorber.

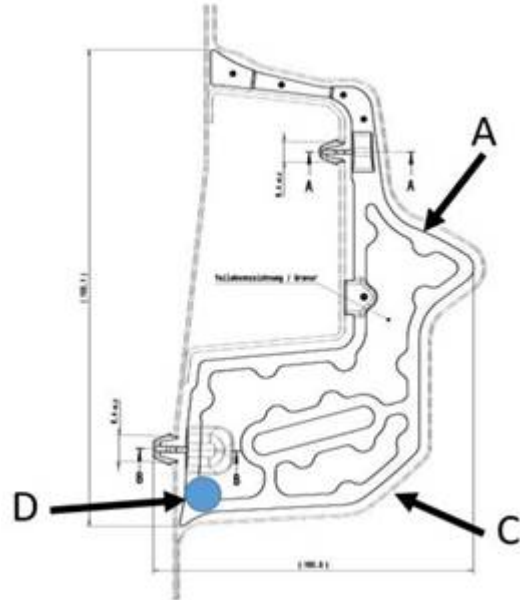
Figure 7. 8mm – 10mm hole to be made through the sound absorber.

7. Figure 7 shows a drawing of the sound absorber. The blue dot marked 'D' corresponds with a point through which a hole 8mm – 10mm in diameter will be made. This hole will allow for a normal flow of any accumulated water to reach the normal drainage and exit the sill cavity. The method for creation of this hole follows.

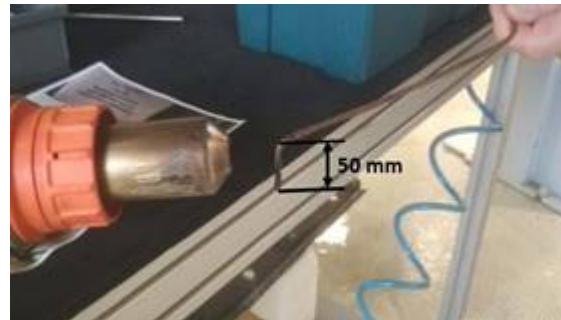
Figure 8. Heating the fabricated tool.

8. From a steel rod 8mm – 10mm in diameter fabricate a tool as shown in figure 8. Bend the end of it in an 'L' shape 50mm long. Heat the bent end of the rod to approximately 500 °C (~932° F).

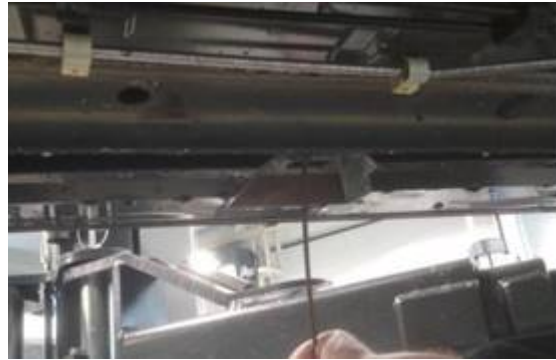
Figure 9. Making the hole in the sound absorber.

9. Guide the heated rod into opening number 4 from Figure 3 and melt a hole in the sound absorber in position 'D' from figure 7 (Figure 9).

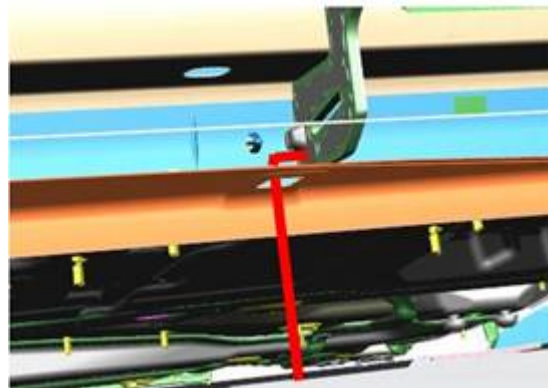
Figure 10. Correct positioning of the heated rod.

10. Figure 10 shows a drawing of the operation performed and the correct positioning.

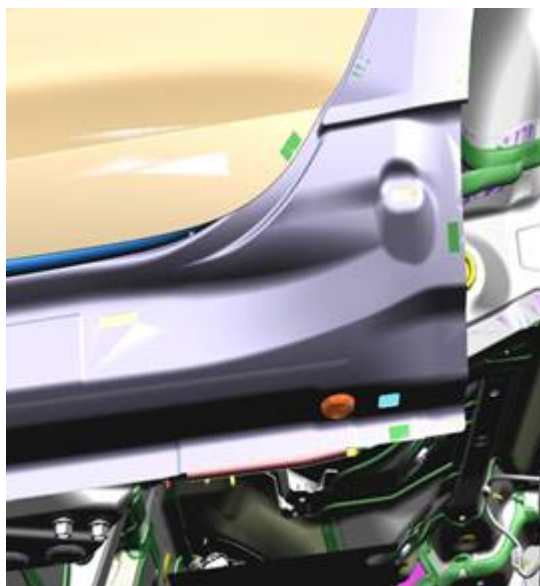
Figure 11. Drain plug on rear of the side member.

Ensure that the drain function of the draining plugs on the front and rear of the side members are fully functional and not damaged (Figure 11).

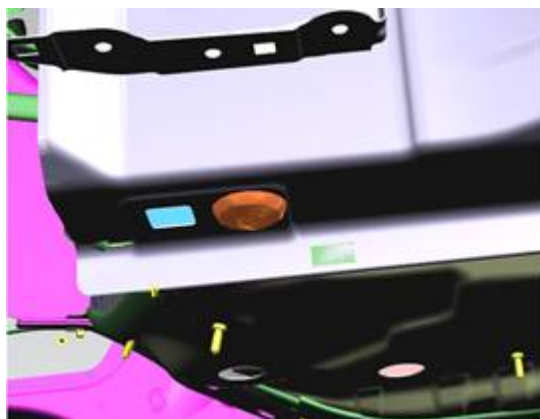
Figure 12. Drain plug on the front of the side member.

12. Figure 12 shows the drain plug on the front of the side member.
