# Technical Service Bulletin

**57 Power closing door latch is intermittently inoperative, door adjustment is required**  
**57 22 89 2058159/4 January 19, 2022. Supersedes Technical Service Bulletin Group 57 number 21-83**  
**dated September 15, 2021 for reasons listed below.**

Model(s)	Year	VIN Range	Vehicle-Specific Equipment
Q7 and SQ7	2016 – 2023	All	Power closing door latch

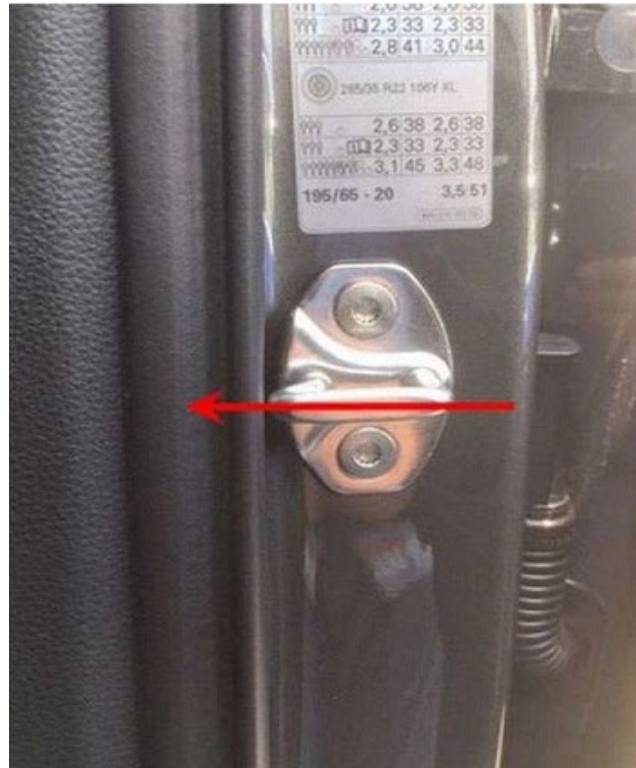
does not provide enough counter-pressure for the latch, the door control module does not recognize the door latch signal long enough or at all. Hence the door will not be closed.

*Figure 1. Adjust door striker inward by at least 0.5 mm.*

At the same time, adjust the door striker inward as far as possible (at least 0.5 mm) (Figure 1). The front door can be flush or slightly under flush to the rear door without causing a wind noise concern (Figure 2).

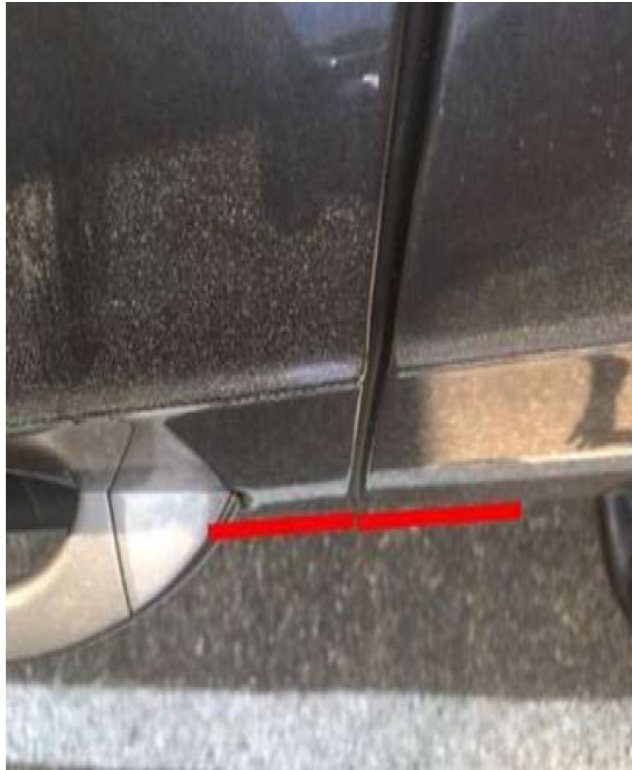
*Figure 2. The front door can be flush or slightly under flush to the rear door.*

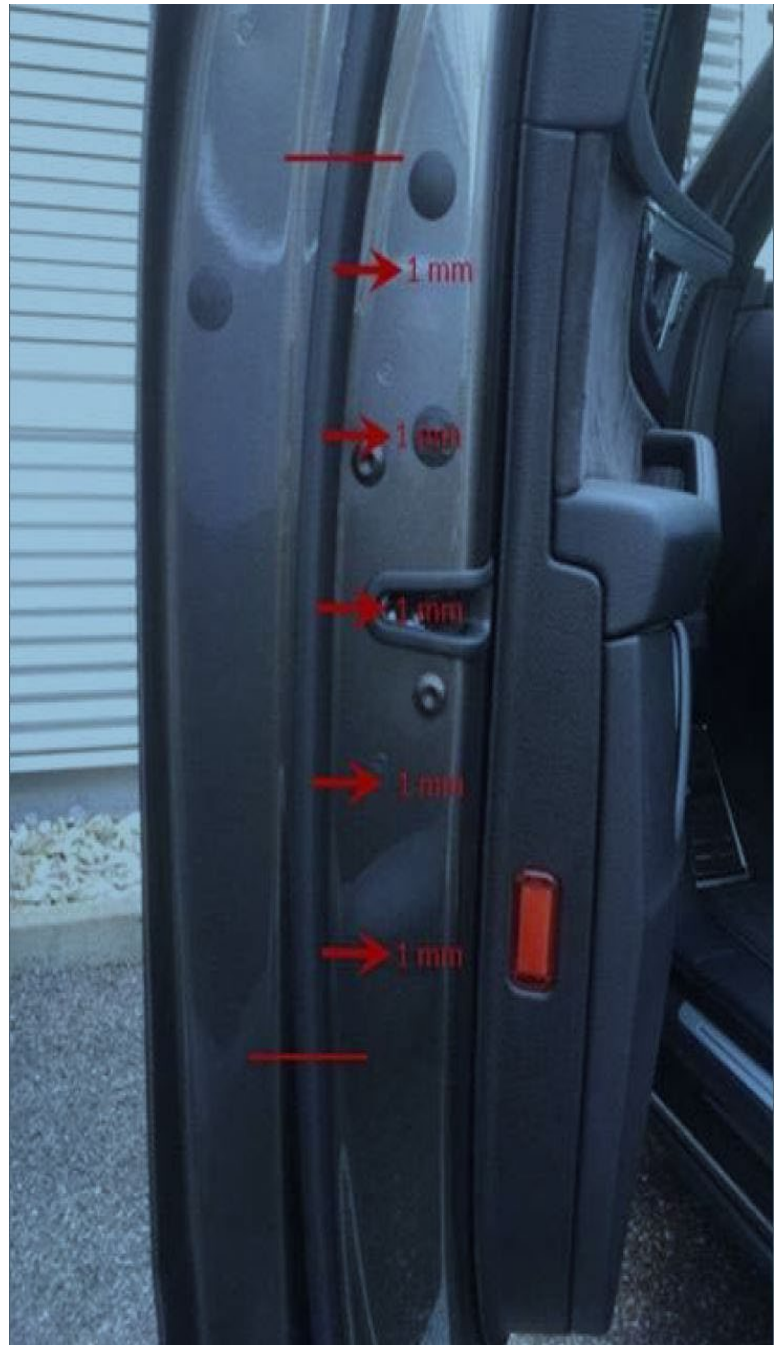
*Figure 3. Install the new outer door seal with an inward offset of 1.0 mm.*

If the customer concern persists, install a new outer door seal with an inward offset of 1.0 mm when compared to the original door seal location (Figure 3).

**Tip:** Mark the position of the original outer door seal before replacing it.
